# History Uncovered

*After a flood ravaged a late-19th-century covered bridge in Lancaster County, Pennsylvania, it took a team of engineers and builders months to inspect the damage and devise a plan to salvage or replace each water-logged member. The result is a new bridge built with 19th-century techniques that accurately re-creates a local treasure.*

.....  
**By Dave Hoglund, P.E.**

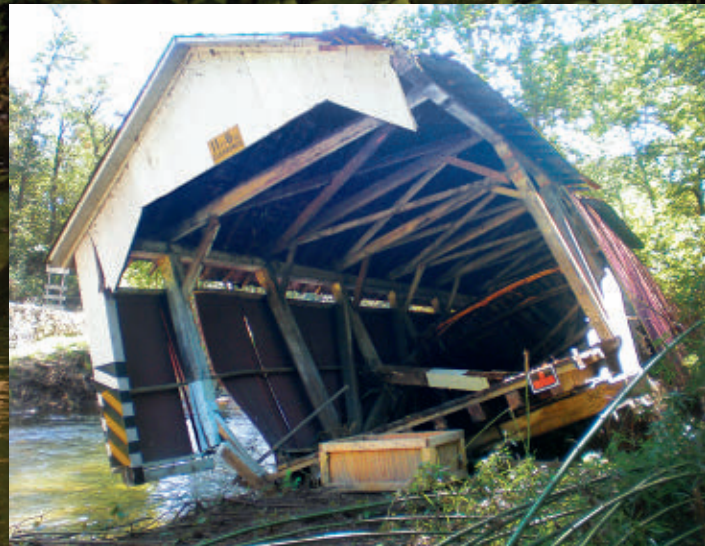
**In September 2011 rising waters generated by the tropical storm Lee forced the 127-year-old Siegrist's Mill Covered Bridge from its abutments and swept it downstream, right. Nearly two years later, the bridge had been reconstructed using designs and techniques common to the late 19th century, the time when it was built. Covered bridge enthusiasts came from many locations to observe the salvaging of the original bridge, the placement of the reconstructed frame, and the ribbon-cutting ceremony.**

After the waters of Chiques Creek receded in September 2011, the structure, which had come to rest on an embankment 100 ft downstream, was safely stabilized and inspected. The structure had sustained extensive damage, but the extent of the harm was not fully visible because the bridge was partially submerged. The county braced the structure with cables and tie-down straps to hold it together to the fullest extent possible until it could be moved. The team also anchored the bridge to the embankment to minimize the possibility of it being washed downstream by another storm.

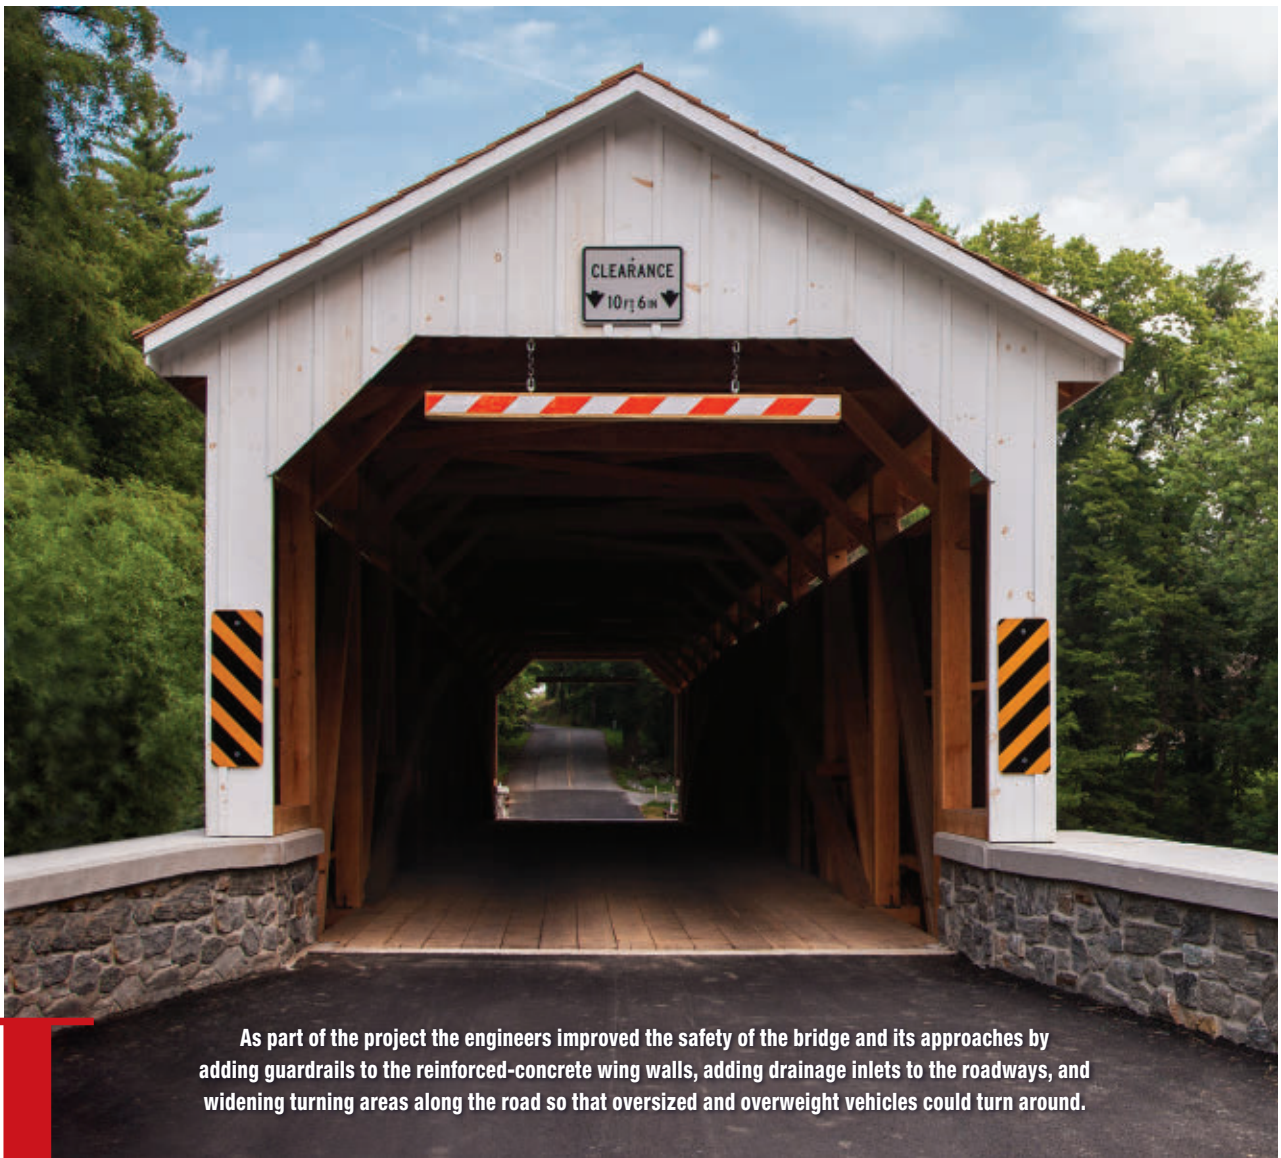
**As part of the project the engineers improved the safety of the bridge and its approaches by adding guardrails to the reinforced-concrete wing walls, adding drainage inlets to the roadways, and widening turning areas along the road so that oversized and overweight vehicles could turn around.**

As an additional part of the bridge restoration project, RETTEW's engineers provided numerous improvements to the site. Because of the region's rolling hills, most covered bridges in Lancaster County feature steep approaches that create blind spots for approaching vehicles. In addition to raising the bridge, RETTEW improved the sight distance for this bridge by elevating the approach roadway and clearing away roadside obstructions. It also provided wider turning areas along the road so that oversized and overweight vehicles would be able to turn around. The roadway design called for drainage inlets to be added in areas that typically experienced ponding. RETTEW's engineers also added standard approach guide rails to the reinforced-concrete wing walls to prevent blunt-end impacts.

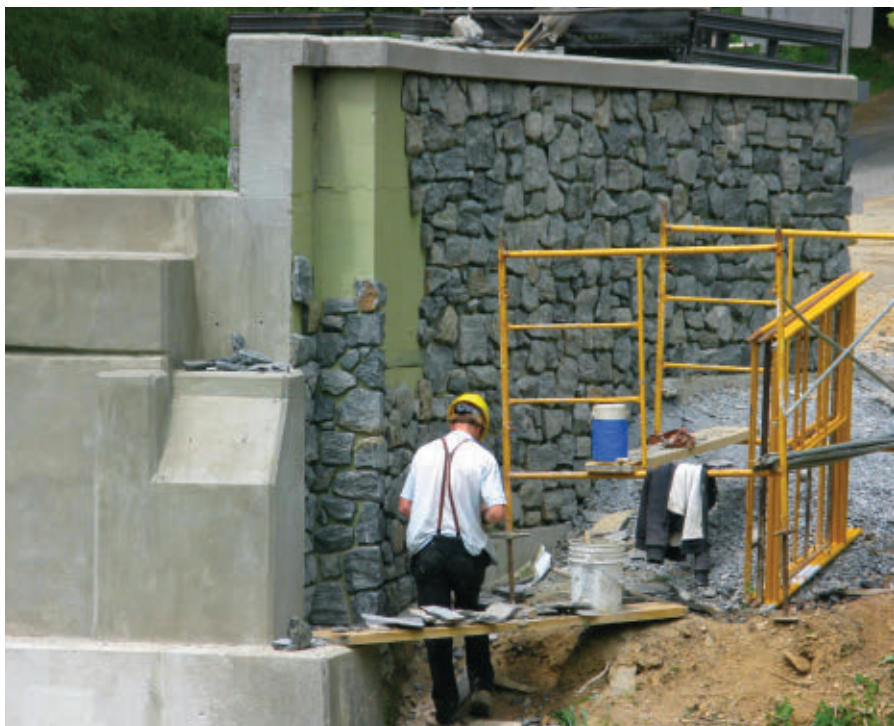
**The engineers specified a stone masonry facade for the interior and exterior walls of the new abutments so that the walls would blend with the remaining abutment foundations and the environment of the surrounding area.**

RETTEW specified a stone masonry facade on the interior and exterior walls of the abutments, and recessed sections of the concrete walls were detailed to accept the stone facade.
