## Blenheim Bridge, a Restoration

**I**N December 2011, *Timber Framing* published an article by Jan Lewandowski about the Blenheim, NY, covered bridge, presented as "a Remembrance" since it had, just months earlier, been washed from its abutments by the flooding Schoharie Creek. In his article, Mr. Lewandowski reflected, "It's unlikely that any framer will ever again construct an object this ambitious in timber." This unlikely opportunity presented itself in the form of an invitation to bid. As we sought to learn more about the scope and scale of the project, the prospect did indeed seem excessively ambitious. Having had just enough experience in repairing and rebuilding covered bridges here in Pennsylvania to have been struck with the desire to do more, the idea of putting together a proposal for the reconstruction of the mighty Blenheim bridge was intoxicating. Thankfully, we had the good fortune of aligning ourselves with Stan Graton, a descendant of Bridgewright Milton Graton. Stan's guidance, based on vast experience, brought balance and skill to our raw ambition. Being awarded the contract for the design and manufacturing of this giant was quite exciting, and once the reali

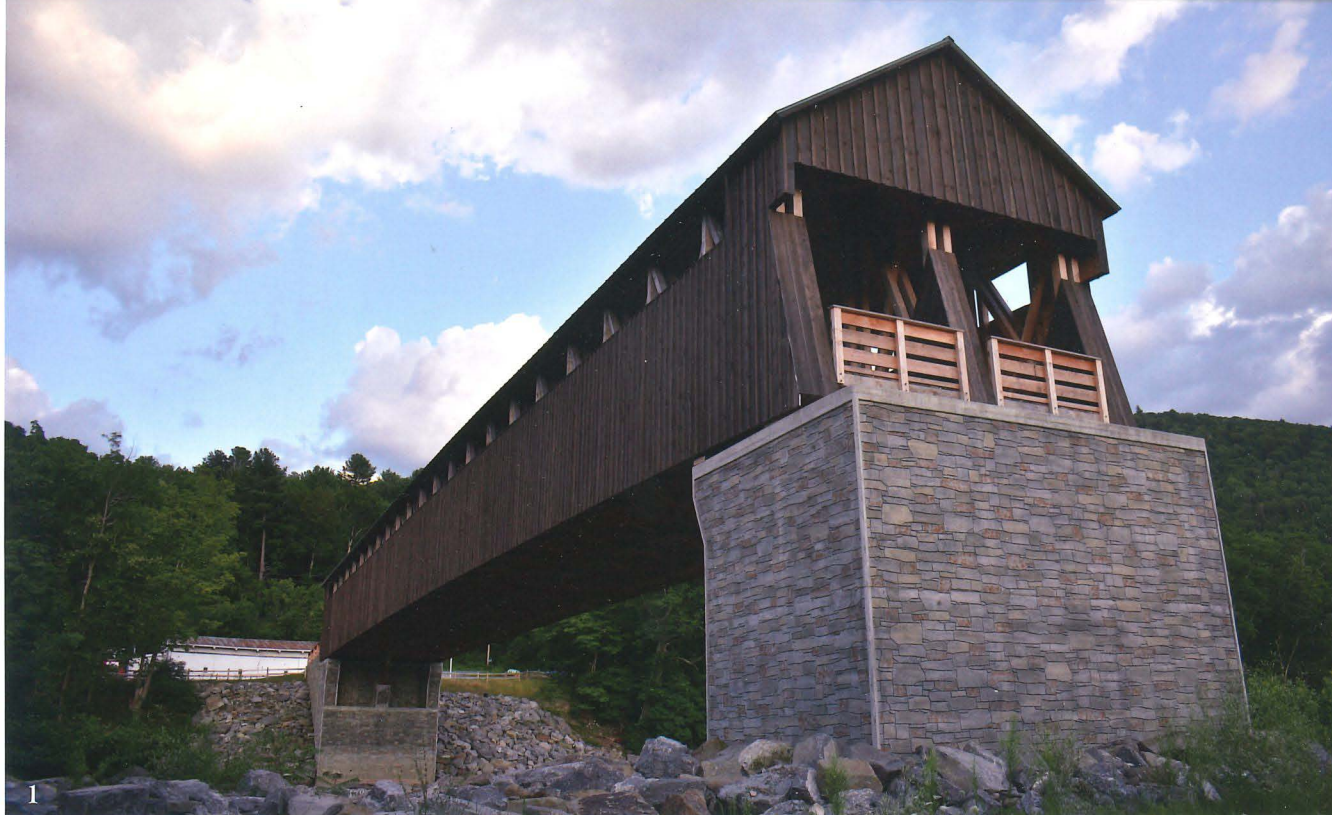
**1** As viewed from the west shore, the new abutments of the bridge stand approximately 11 ft. higher than the original.

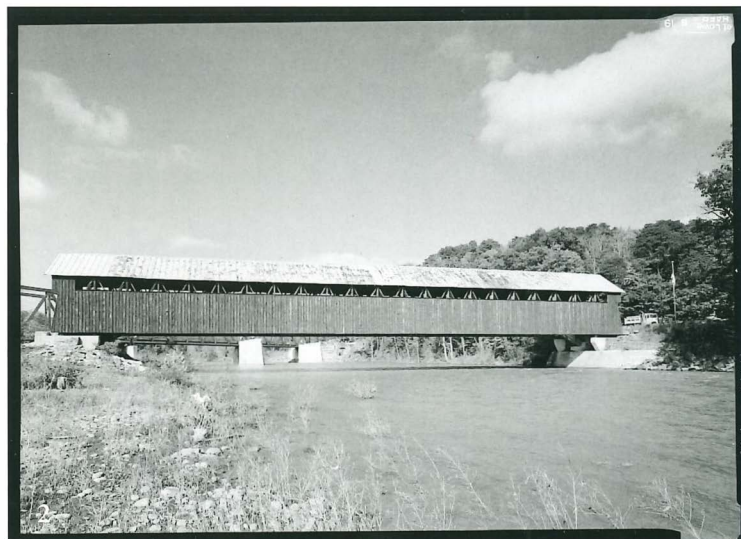
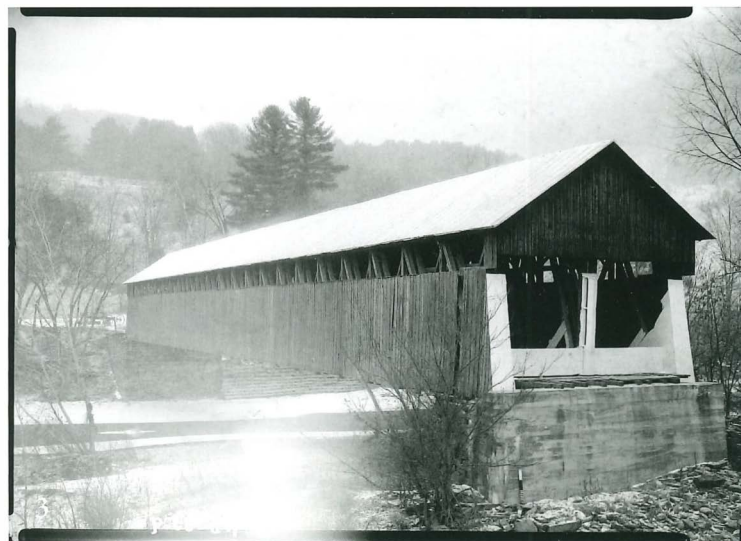
2 Photographs of downstream elevation (1938 survey).

3 View from west shore (1938 survey).

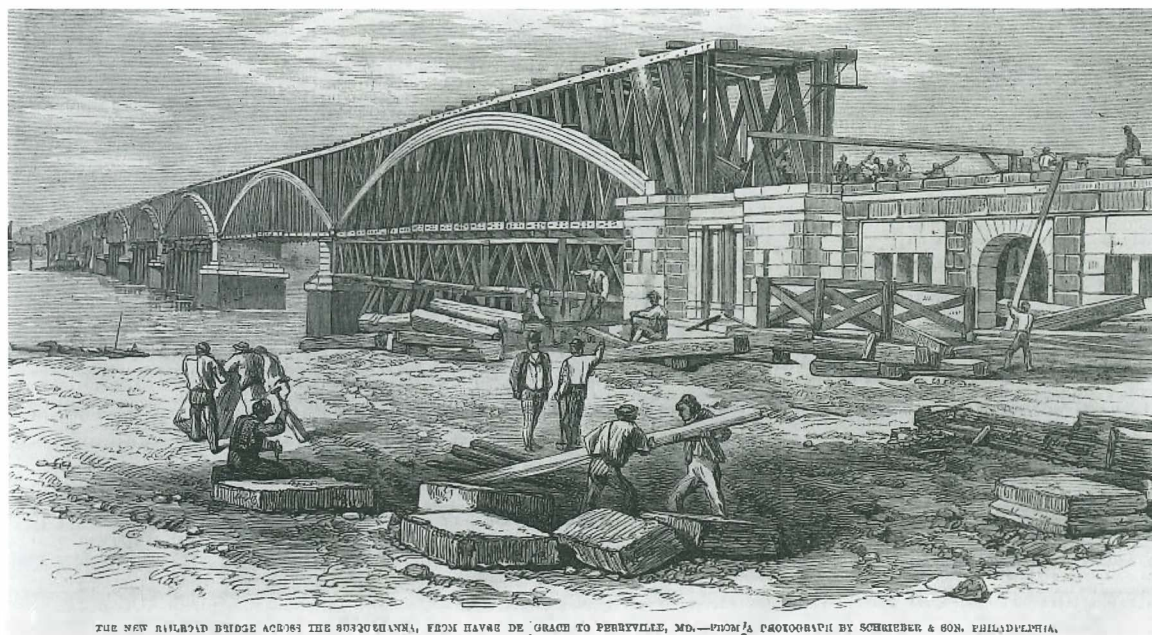
4 Drawing of Philadelphia, Wilmington, and Baltimore Railroad bridge being built by workers directed by Nichols Powers in 1866. Note the falsework supporting the closest span still under construction as compared to the spans already completed beyond (engraving from *Frank Leslie's Illustrated Newspaper*, Dec. 22, 1866, p. 217).

In 1886, Powers did go on to build the PWB (Philadelphia, Wilmington, Baltimore) Railroad bridge across the Susquehanna River in Havre de Grace, MD, which consisted of 12 spans of 250 ft. and a draw span of 175 ft. It would be amazing to see a wooden bridge that was over 3000 ft. long but unfortunately the original was replaced by a steel structure (see Fig. 4) soon after, demonstrating the fast pace of the changes occurring during the industrial revolution.

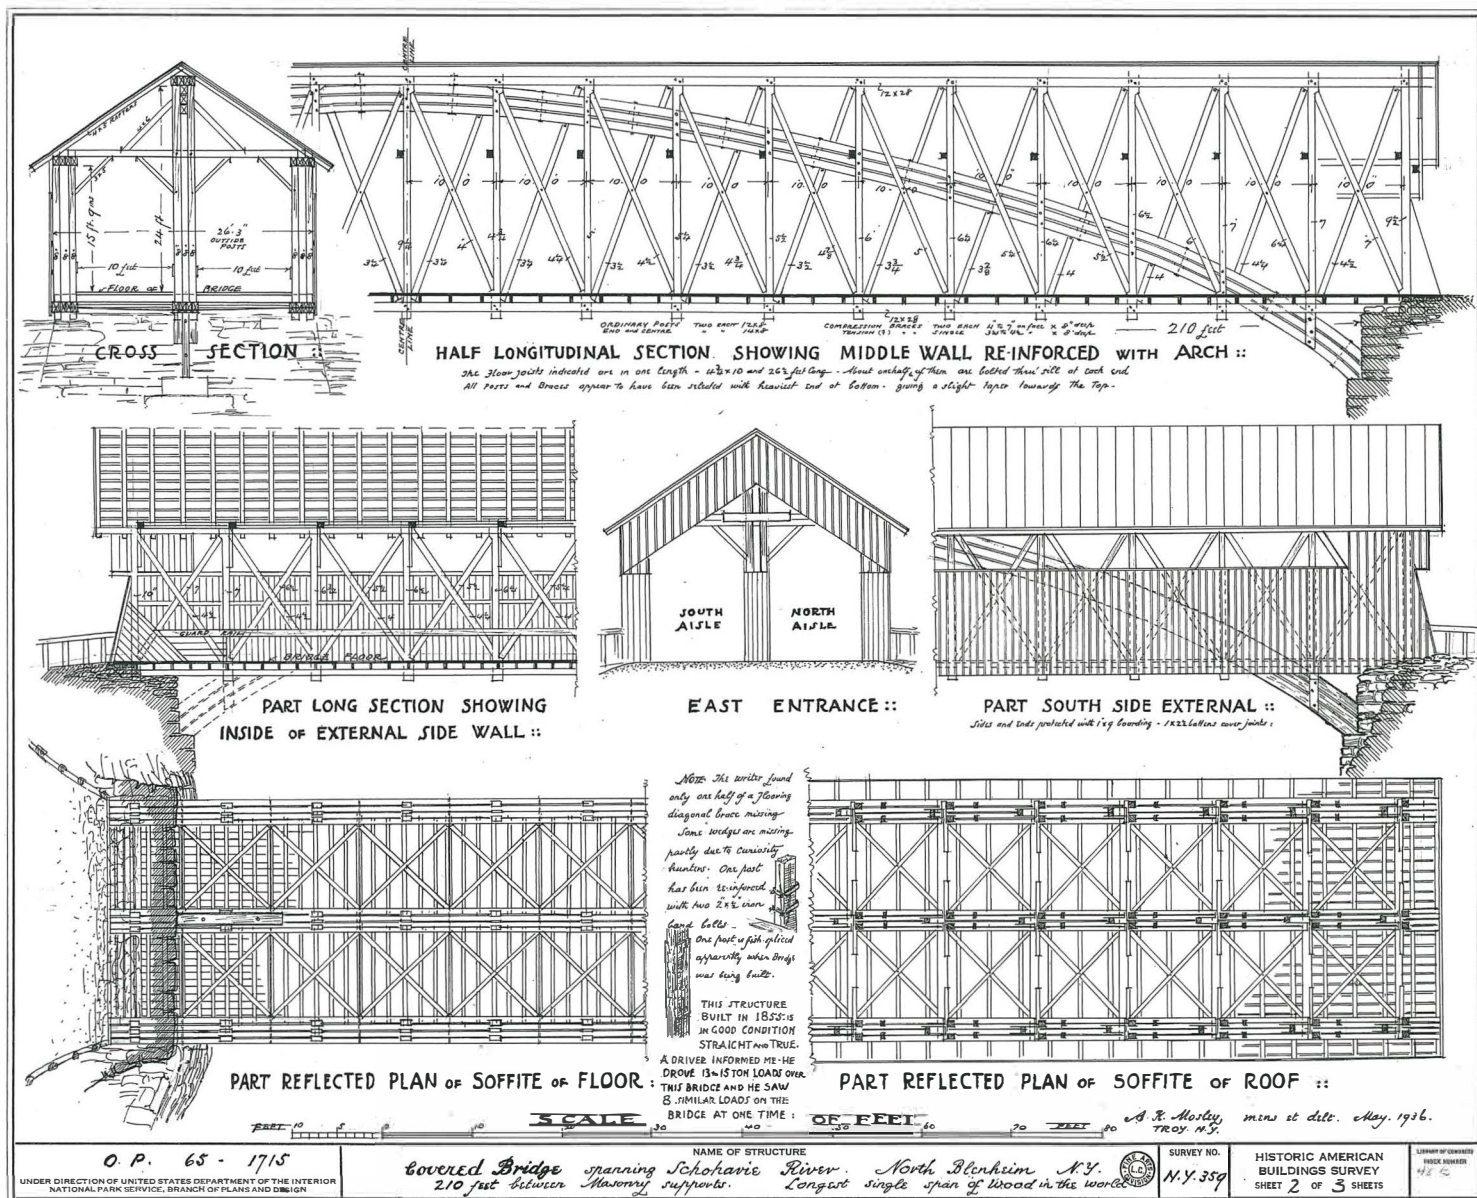
HABS NY-359

5 Part of a set of drawings from the 1936 Historic American Building Survey showing the various aspects of the bridge configuration and details. This set of drawings was a useful resource to help reproduce much of the joinery since the scant remnants of the frame were mostly destroyed.

In 1936, a series of hand drawings were made by A. K. Mosley for the Historic American Building Survey (HABS) showing the overall configuration, member sizes, and connection details that are found on the bridge (see Fig. 5). The artistic aspect of these

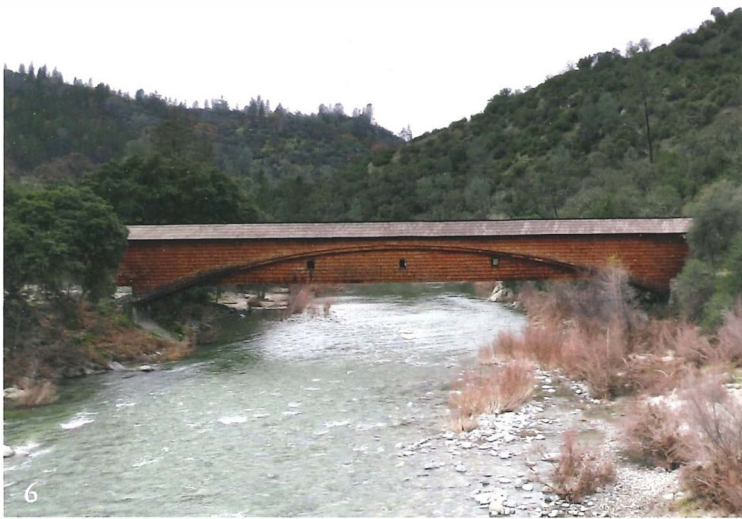
**6** The profile of the auxiliary supporting arch on the outside face of the Bridgeport bridge in Yuba, CA, can be seen clearly under the sugar pine shingle siding.

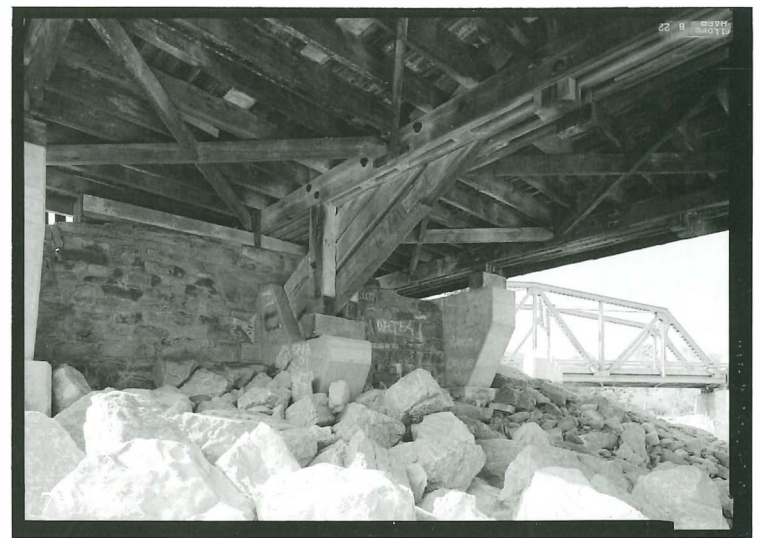
**7** The concrete extensions added by Milton Graton in 1972, in contrast to the original stonework, shortened the span but extended the life of the bridge. Note the steel bridge in background which replaced the old Blenheim bridge.

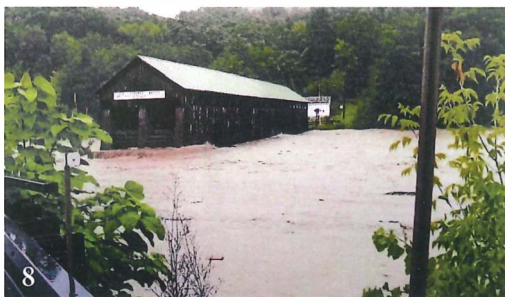
**8** The flooded Schoharie Creek threatens the Blenheim bridge as the water level continues to rise during Tropical Storm Irene in August 2011.

York City and moving slowly north through New York, Vermont, and New Hampshire, flooding nearly every river valley in its path. As with many others, the Schoharie Creek was flooded beyond its capacity. Until Irene, the Blenheim bridge had withstood many floods but as the flood waters rose, the bridge began to lift from its foundation, enough that the force of the rushing waters carried it away until it encountered the Route 30 steel and concrete bridge just downstream. The water level reached just below the new bridge, and the mass of the timber structure floating down the creek was projecting out of the water just enough that the entire structure was sliced right in two with the roof framing settling on the unyielding concrete bridge and the rest of Nichols Powers's masterpiece passing underneath like so much firewood.

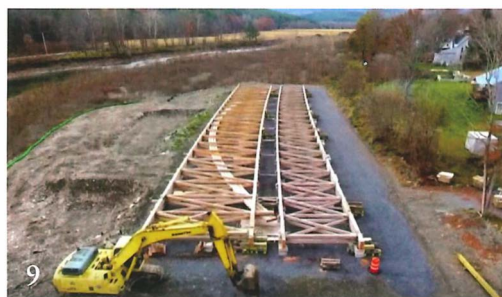
**9** Two trusses, the interior and one of the exterior trusses, are assembled on a frame of steel tubing. The camber of the trusses is evident even from this distance.

the timeline of the project, not to mention the cost. Fabrication of the timber components started early in the summer of 2017, and assembly of the 30-ft.-tall interior truss and north (downstream) truss began a few months later. The trusses were assembled lying flat on a grid of steel beams and then stood up using two large crawler cranes, moved into position, and braced together.

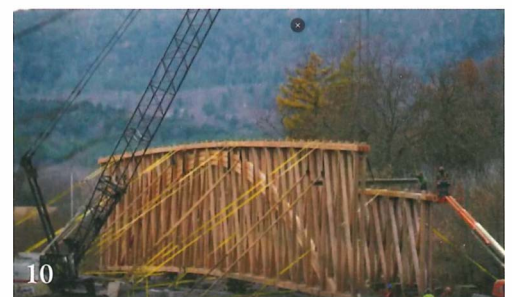
**10** Two crawler cranes support the interior truss as bracing is installed. There is just enough room in the laydown area for the remaining exterior truss to be assembled and stood up in the same manner.

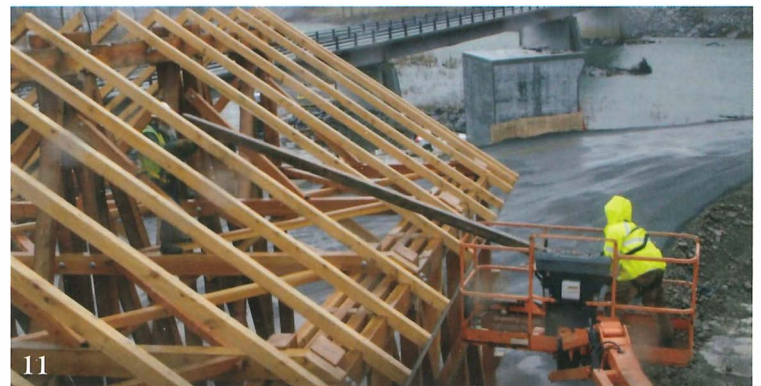
**11** One rafter saved from the original structure was installed in the new roof as a remembrance of the structure that Nichols Powers built over 150 years earlier.

By late fall of 2017, the main structure of the bridge was assembled. As winter approached, the roof rafters and then the siding were added. The metal roofing was left off for fear of any distortion to the materials during the moving process. The goal was to assemble as much of the material that would be difficult to install from the outside since, once the bridge was moved into position, access would be significantly limited. One sentimental aspect of the reconstruction was the inclusion of a requirement that one token rafter from the original bridge be reused in the new rebuild. This rafter was selected from the pile of timbers rescued from the creek and stored in a local barn with the hope that it might someday be reconstructed (see Fig. 11).

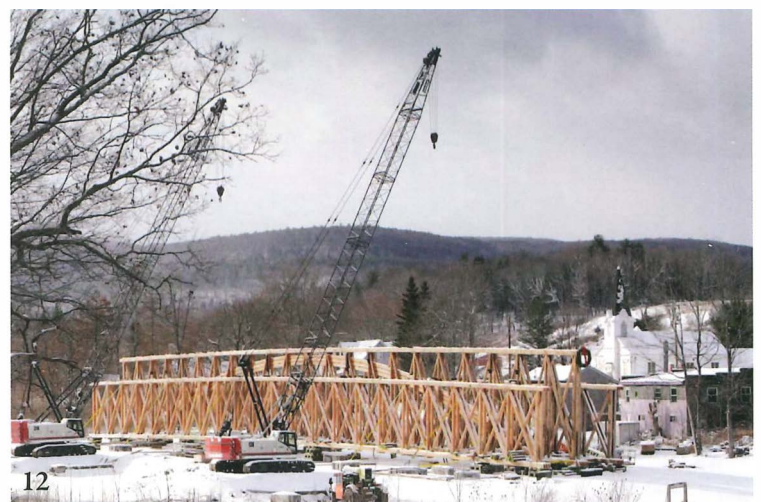
**12** Completed timber structure ready for roof framing and siding.

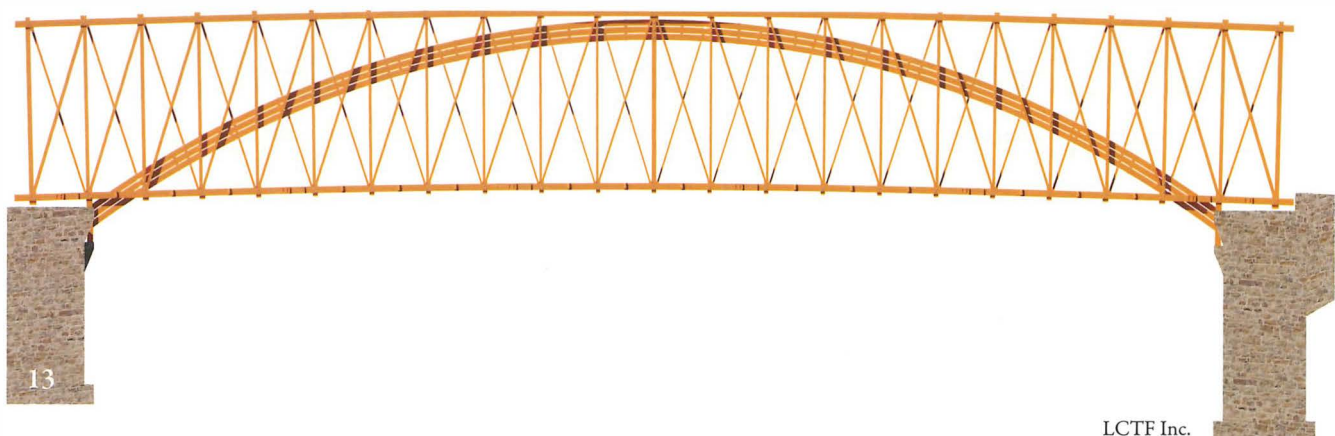
**13** CAD drawing of the interior Howe truss, 28 ft. tall, featuring the tripled arch enclosed by double posts and quadripartite bottom chords. The confluence of these members at the point where the arch passes through the bottom chord results in seven layers with intersecting joinery.

The interior truss featured a tripled arch of 9x11-in. members that passed right between the double posts, at the centerline of the bridge axis, to serve as the backbone for the entire structure. The arch extends from approximately 6 ft. below the floor deck all the way up to the underside of the top chord, functioning as a ridge beam (see Fig. 13); the resulting height of the truss is 28 ft. At the point where the arches pass through the bottom chord of the truss (which is also at a vertical panel point) there are seven layers of timber members passing by each other, all of which are bolted together. The resulting pattern of lap joints necessary for this to occur is exquisitely complicated.

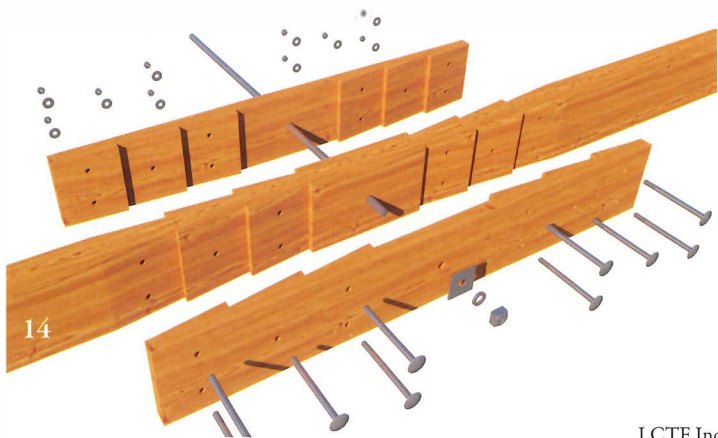
14 Exploded view of the bolt-o'-lightning fish splice joint.

One particular connection which was essential for the success of the bridge structure was the bolt-o'-lightning splice joint which occurred at every point where the bottom chords needed to be spliced together (see Figs. 14–17). This joint requires two 6-ft.-long fish plates, each with six tapered bearing shoulders, three on each side of the joint, that engage with similar bearing shoulders in the end of each bottom chord. These fish plates are then bolted together, creating quite a large amount of surface area to transfer the tension through the joint. Since there are four-member bottom chords in each of the three trusses, the joints are staggered in each of the four layers, one joint to a panel, occurring in 66 locations and requiring 132 fish plates. Based on some rough calculations, the capacity of this joint is approximately 35,000 pounds.

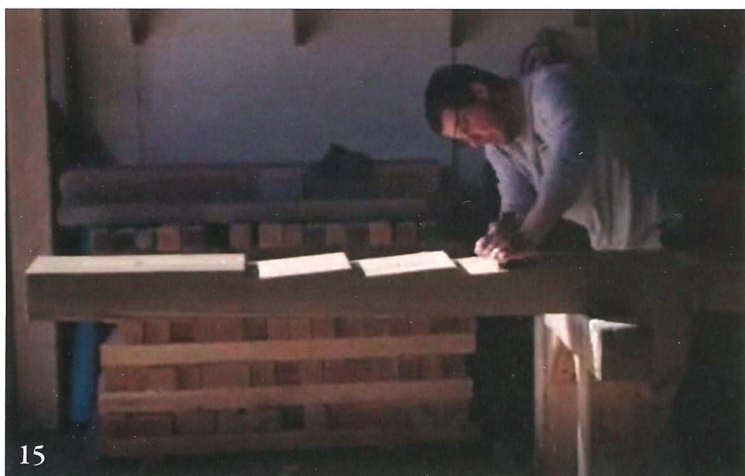
15 LCTF shop foreman, Mike Eenigenberg, demonstrating the carving of a fish splice joint.

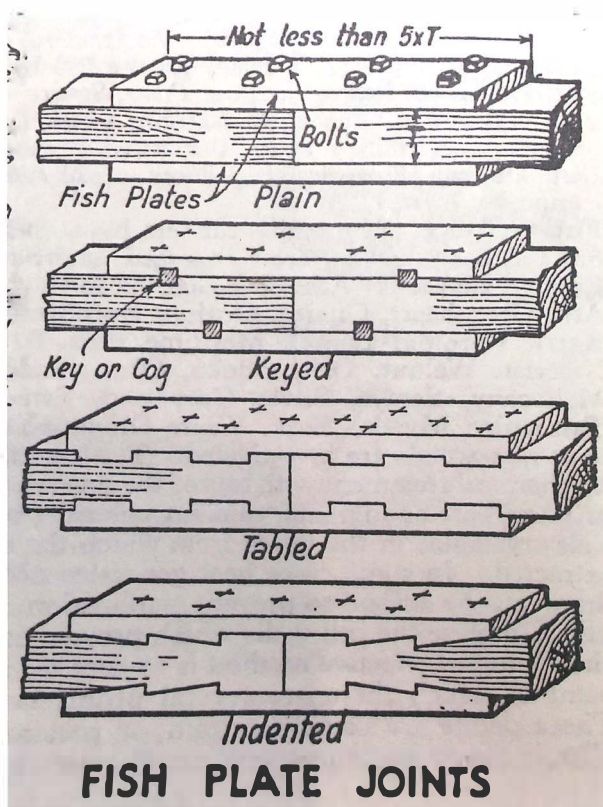
16 Diagram of various types of fish plate joints. Thomas Corkhill, *The Complete Dictionary of Wood* (New York: Dorset, 1980).

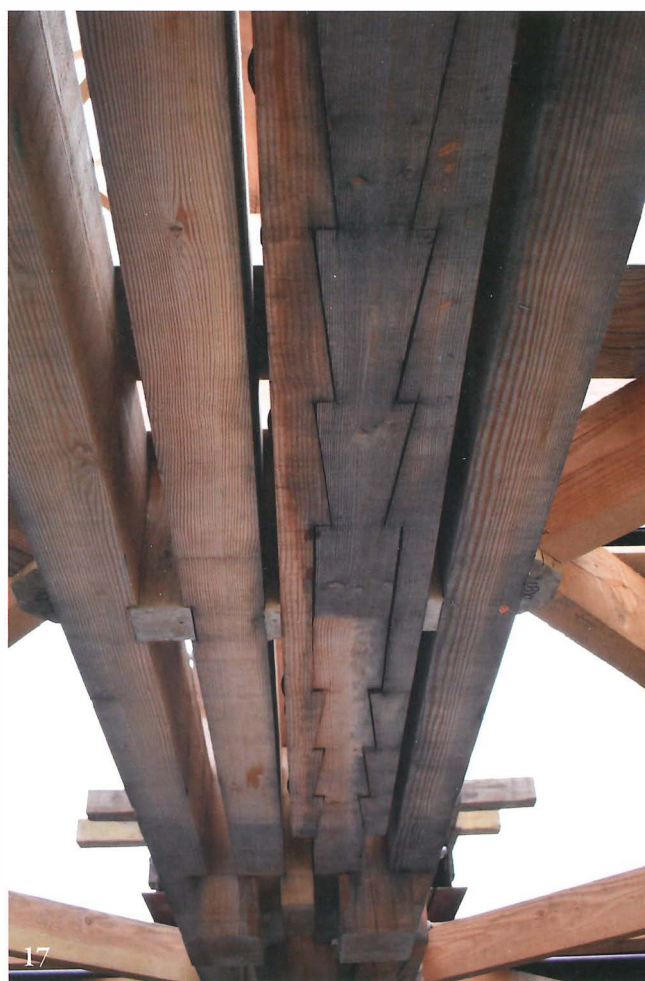
17 Assembled fish plate joint as viewed from below.

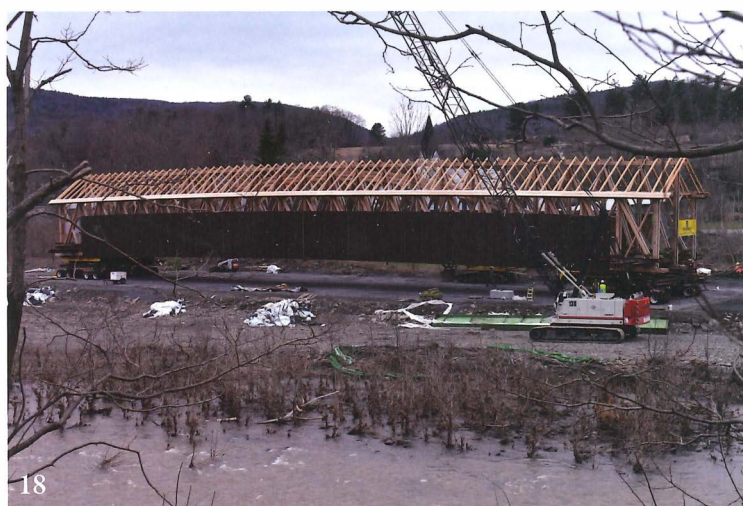
18 The Blenheim bridge is ready for the move from the staging area, across the temporary bridge, and up onto the abutments.

**On the road** In the spring of 2018, the bridge was assembled and ready to relocate, the abutments were ready to support the bridge, and the remaining task at hand was to move a 425,000-lb. timber structure across the creek and then lift it nearly 20 ft. to set it on the abutments (Figs. 18–26). The father and son team of professional house movers, Jerry and Gabe Matyiko, were instrumental in making this impressive feat possible. One basic trait of this type of structure, namely that it was designed to be supported at each end and therefore does not require any support along the length, made this approach possible with a relatively simple system. Using a fleet of eight hydraulically controlled axles, four on each end of the bridge, the entire bridge structure was essentially driven across a temporary steel and timber roadbed. Very few structures of this size and weight are designed with so few support points, which made this project a perfect fit for the hydraulic axle system. Once the

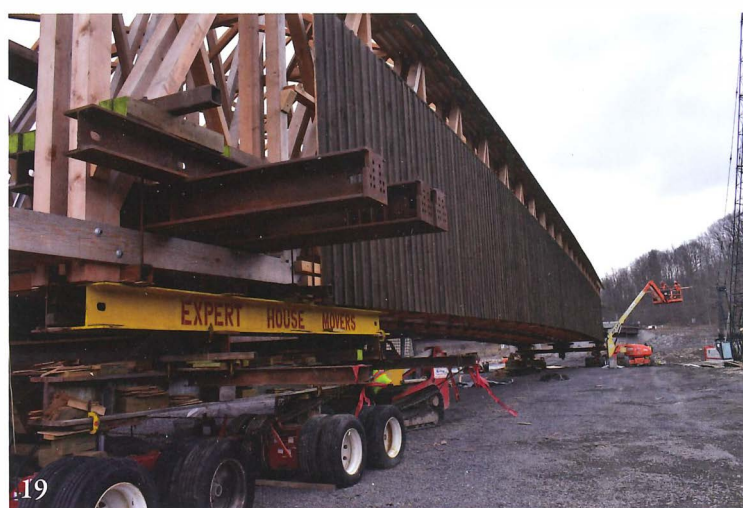
19 The needle beams can be seen extending through the timber structure. Each end of the bridge was supported by four hydraulically controlled axles that take the weight and allow each end to be steered independently.

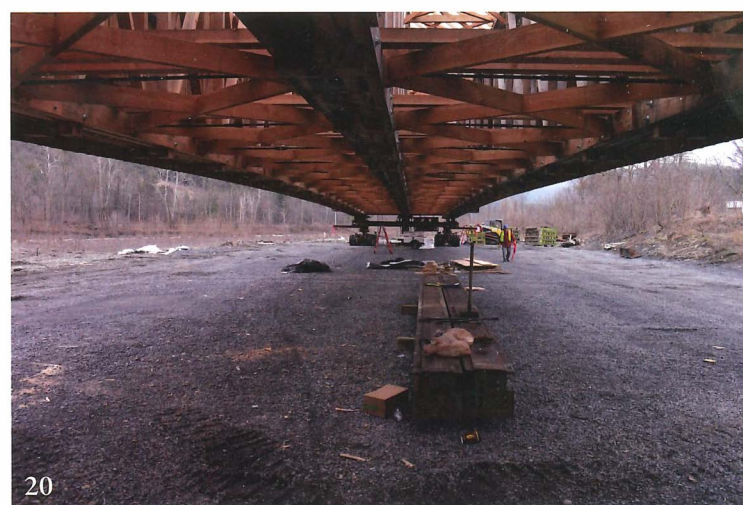
20 View of the underside of the bridge just before it began to roll.

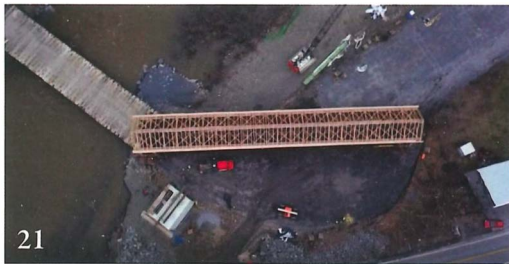
21 The trajectory of the bridge as it was directed into position is evident in the aerial view.

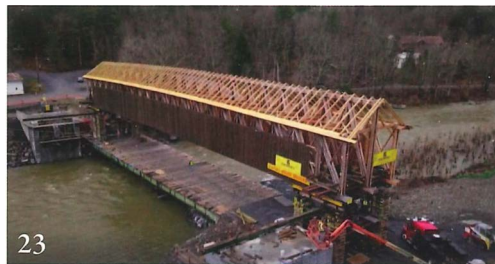
23 The Blenheim bridge has been rolled into position and is starting its ascent to the top of the new abutment.

The next step in the process was to lift the bridge to the correct elevation in order to slide it sideways over the abutments. This was accomplished with a straightforward process using hydraulic jacks and cribbing to slowly raise the bridge upward. Cribbing was added with each lift of the jacks and the jacks were then moved up one step, repeating the process again and again until the bottom of the bridge was above the top of the abutment. Needle beams, which are steel I-beams threaded through the timber structure to create additional support points, were then fed in from each side. This allowed the entire bridge structure to be slid sideways over the abutments. Load-rated rollers allowed the hydraulic jacks to push the bridge along the needle beams in a similar manner to the lifting process. Jacks pushed the bridge, released, reset in the next position, and then pushed again. Once the bridge was in position over the abutments, the final remaining step in the process was to lower the bridge, using the cribbing and jacking process in reverse, until the arches, lower chords, and bearing posts all rested on their custom-fit bearing blocks.

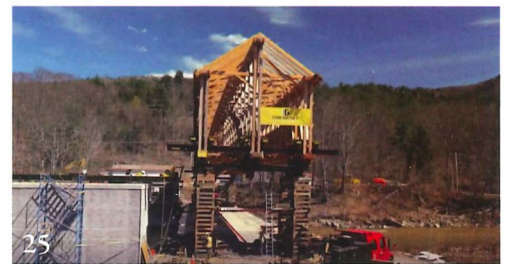
25 Viewed from the end, the stacks of cribbing that will support the bridge as it is lifted are just getting started.

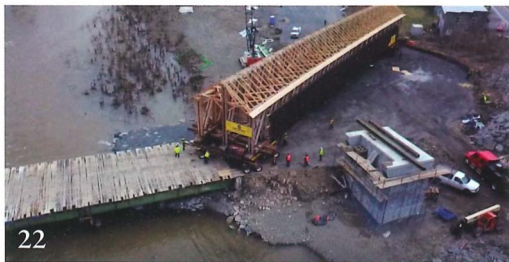
22 Even at the last minute, it was necessary to excavate more of the bank behind the bridge so that it was able to swing into alignment with the temporary bridge.

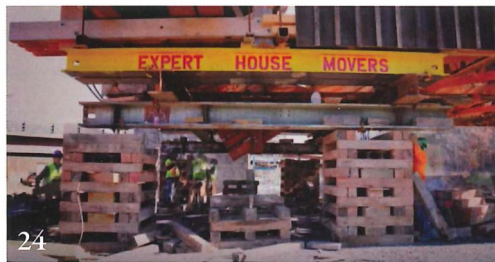
24 Detail of the cribbing that will support the bridge as it is lifted.

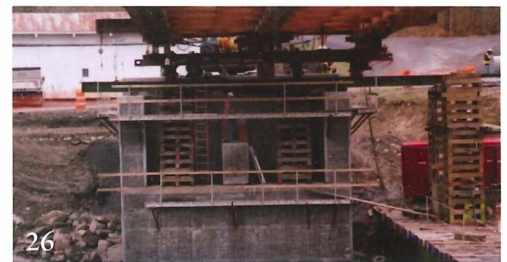
26 Once it had reached the correct height, the bridge was slowly pushed laterally across yet another needle beam, using more hydraulic jacks until it was centered on the abutments.

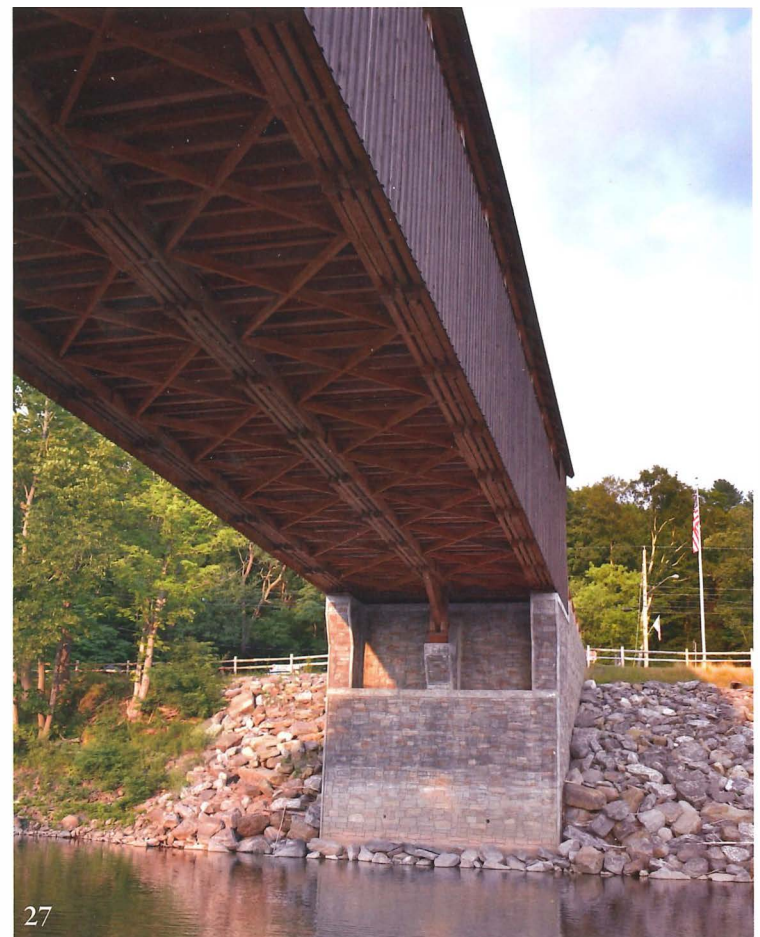
27 Standing high above the Schoharie Creek, the complicated system of lateral bracing and bottom chords are visible from the creek bed.

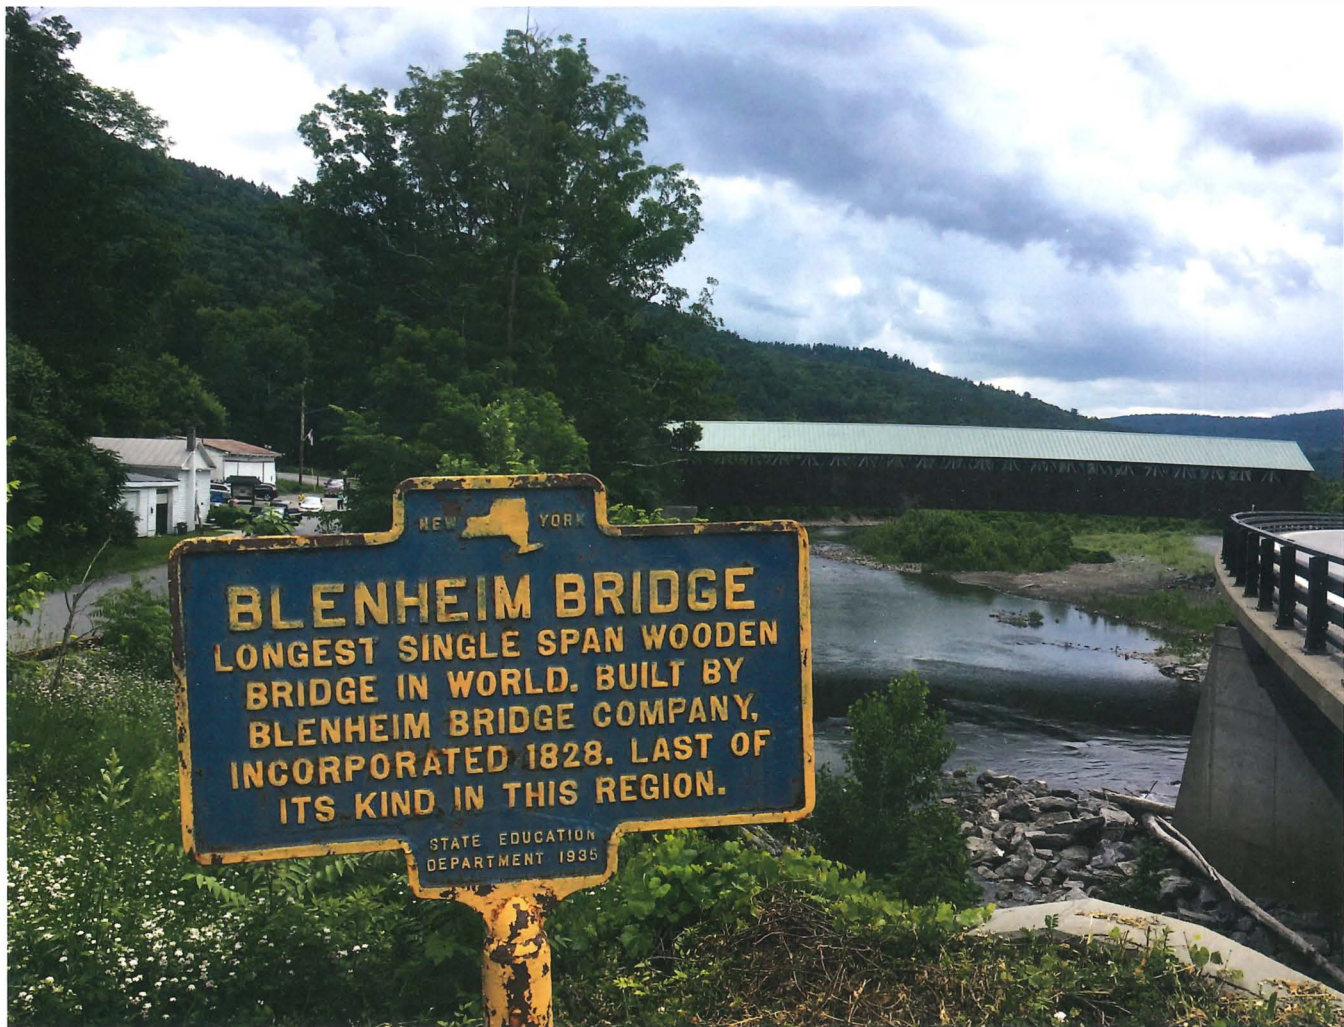
28 After nearly seven years of hard work by many thoughtful and conscientious bridge enthusiasts, the new Blenheim bridge has been rebuilt.
