# Tree Canopy Walk: No Walk in the Park

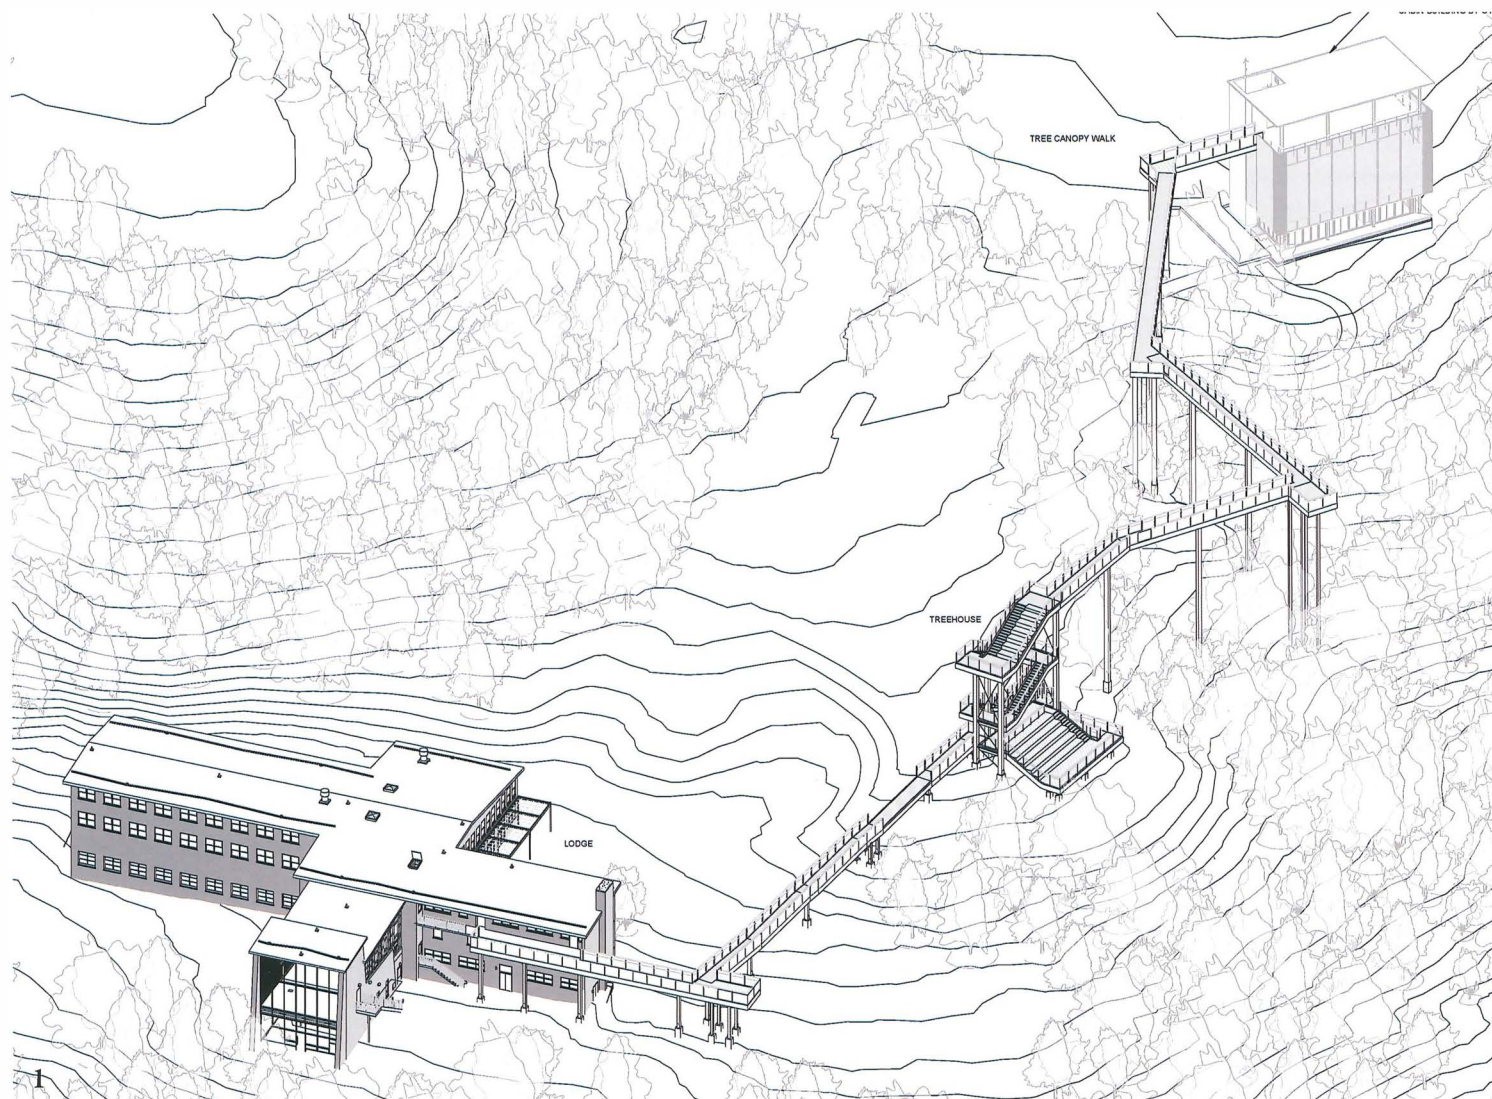
**1** The architect's conceptual model, showing the existing "Lodge" building (lower left of figure) and the proposed "Cabin" terminus building (upper right), presently under construction, with the "Tree House" tower midway along the Tree Canopy Walk.

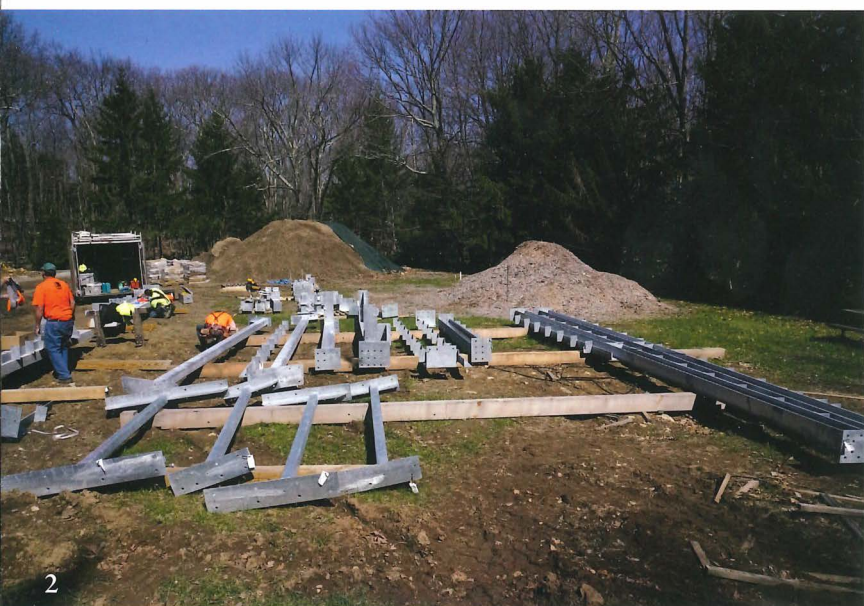
**2 A small sampling of the steel used in the Tree House, shaken out in a field some 1500 ft. from the actual erection site.**

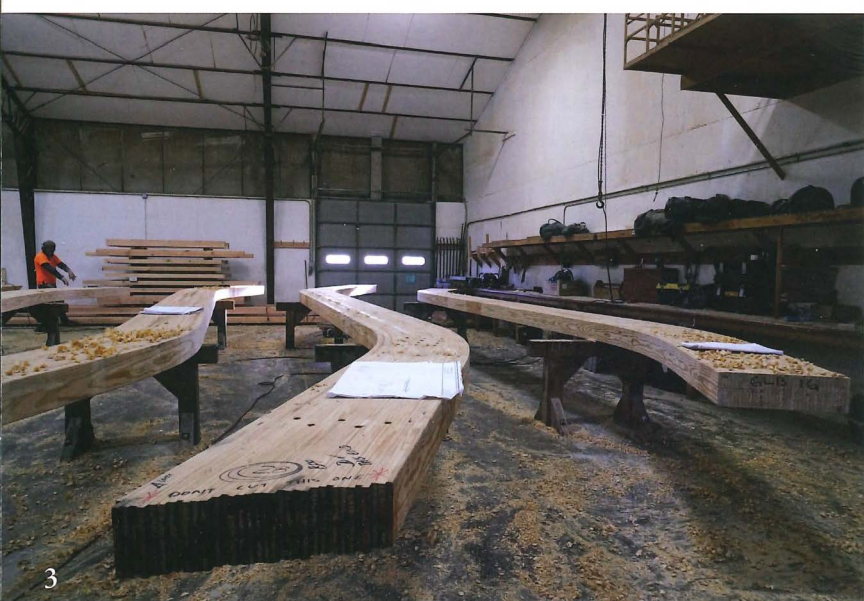
**3 Some of the S-curved glulams for the Tree House bleachers in our shop. The generally poor geometric accuracy of the glulams, especially these curved ones, left much to be desired, and occasioned a lot of head-scratching during layout.**

The most likely candidate for this seemed to be southern yellow pine (*Pinus* spp.), for which we found a source in Alabama. The problem wasn't so much the species, which the client's design team embraced without any resistance, but in getting the engineer of record to accept that the substitution satisfied the structural design criteria. No grade of southern yellow pine could meet or exceed all the design properties of the black spruce glulams we were trying to replace. We finally ended up assuming the specification of 26F-V5 architectural-grade southern yellow pine glulams as the basis for our quote, and this is the grade of glulam that was, in fact, used for the project ("26F" signifies a maximum bending stress value of 2600 psi, and "V5" denotes a balanced layup of laminae in both the core and outer layers of the glulam). (Fig. 3).

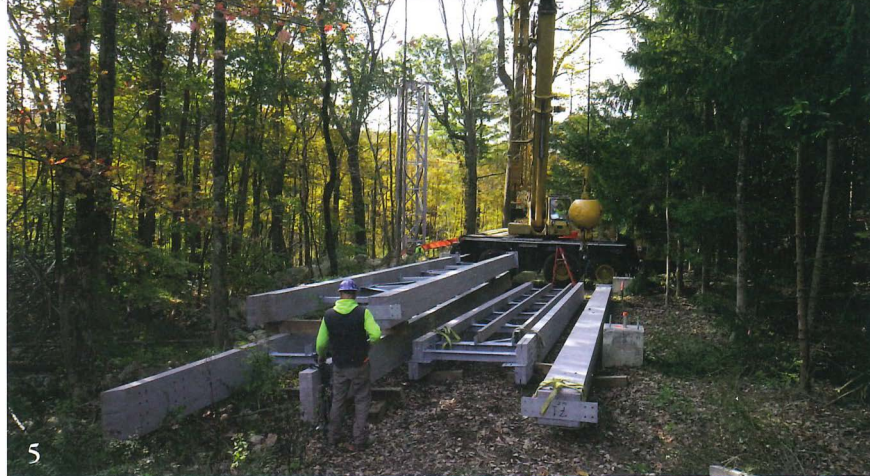
5 Partially preassembled components staged in the woods, being readied for erection. A narrow path through the forest provided good access for the all-terrain crane, allowing us to erect the glulam and steel components with a smaller crane than would otherwise have been needed.

From the very beginning, even while we were still bidding the project, we had decided to assemble the full-size walkway segments in our shop and ship them to the site. There are 17 such segments, most of which are six feet wide by around 35 feet long (Fig. 5). This strategy was driven by two considerations: preassembly would greatly cut down the amount of time needed on site and, thus, prevailing wage rate labor costs; and working in a controlled environment would allow us to solve problems more efficiently. In addition, there are four braced-frame towers—one over 50 ft. tall—that we also intended to ship to the job site partially assembled (Figs. 6–8). And finally, there is the "Tree House," a grand three-story tower with two sets of bleachers (one at the base and another at the top) and five stair runs

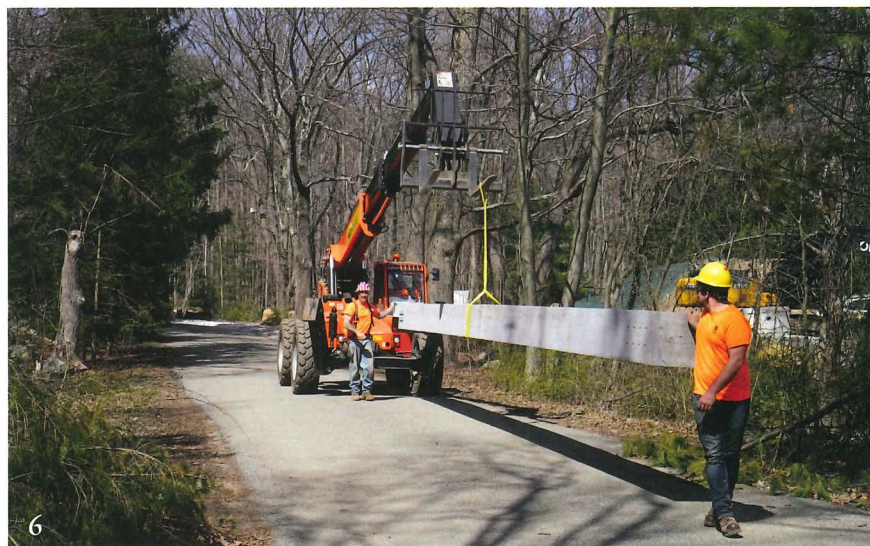
6 Once fitted with steel, the glulam columns were moved the 1500 ft. from the staging area to the build site with a material handler.

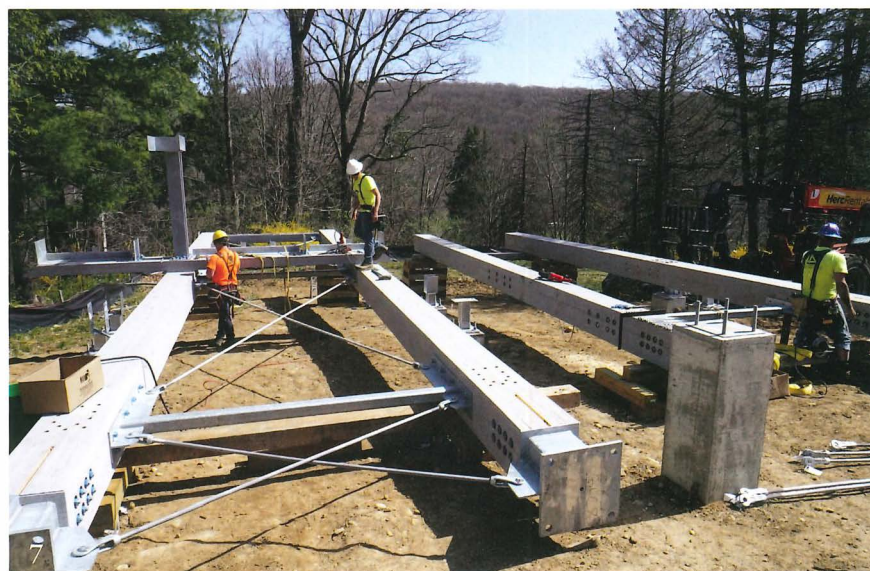
7 Glulam columns and steel connection members for the Tree House prepared for erection. The column assemblies landed on concrete piers, one of which is visible in the foreground.

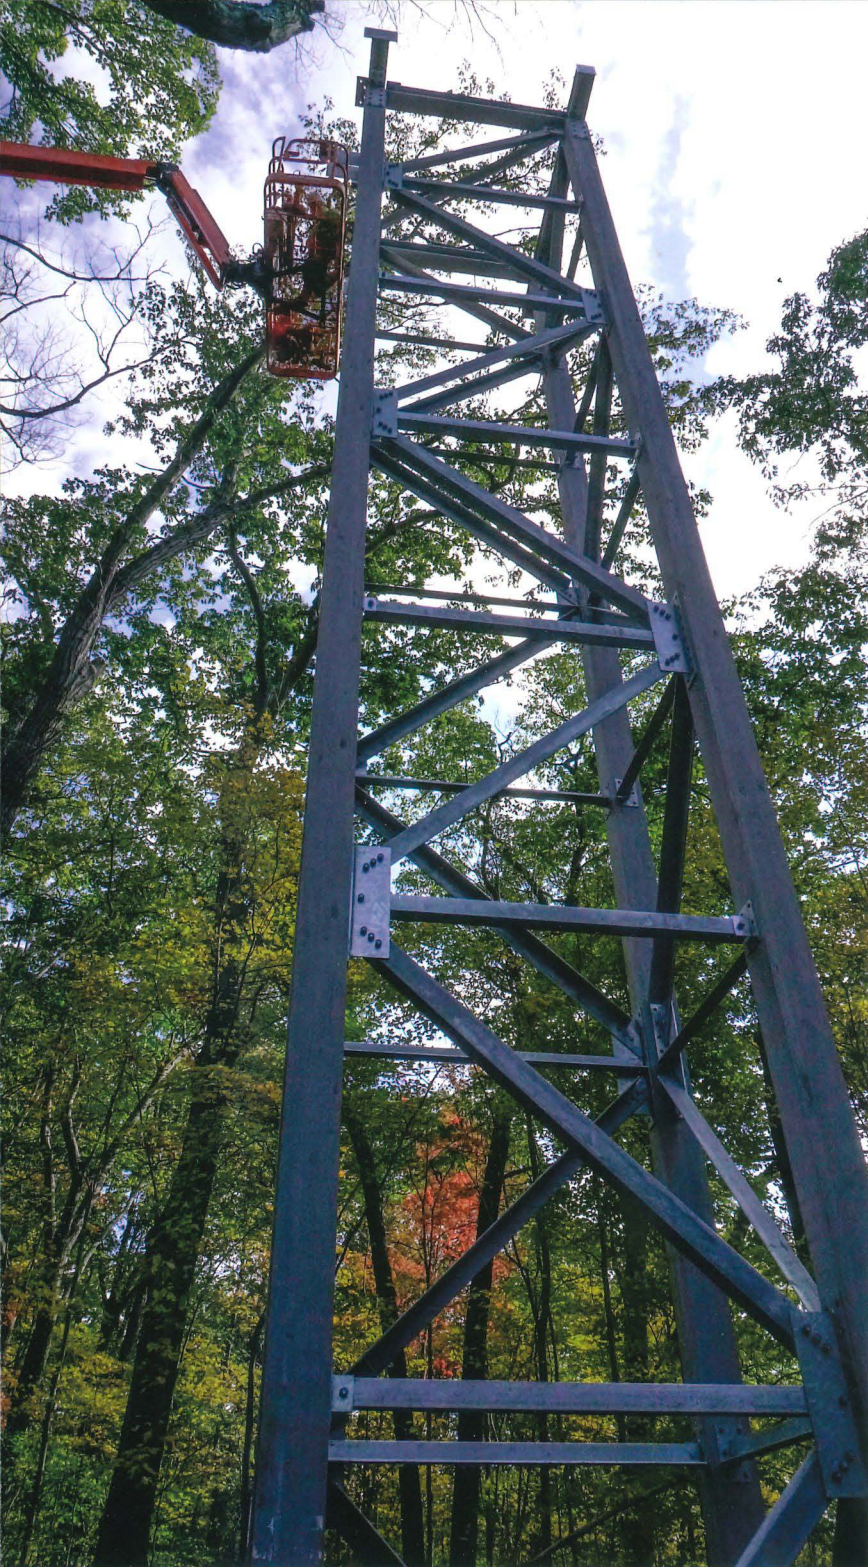
**8** A braced frame tower along the stretch of walkway connecting the Tree House to the proposed terminus building—column glulams each over 50 ft. long. With post base assemblies and concrete piers, the deck of this tower was almost 60 ft. above the forest floor.

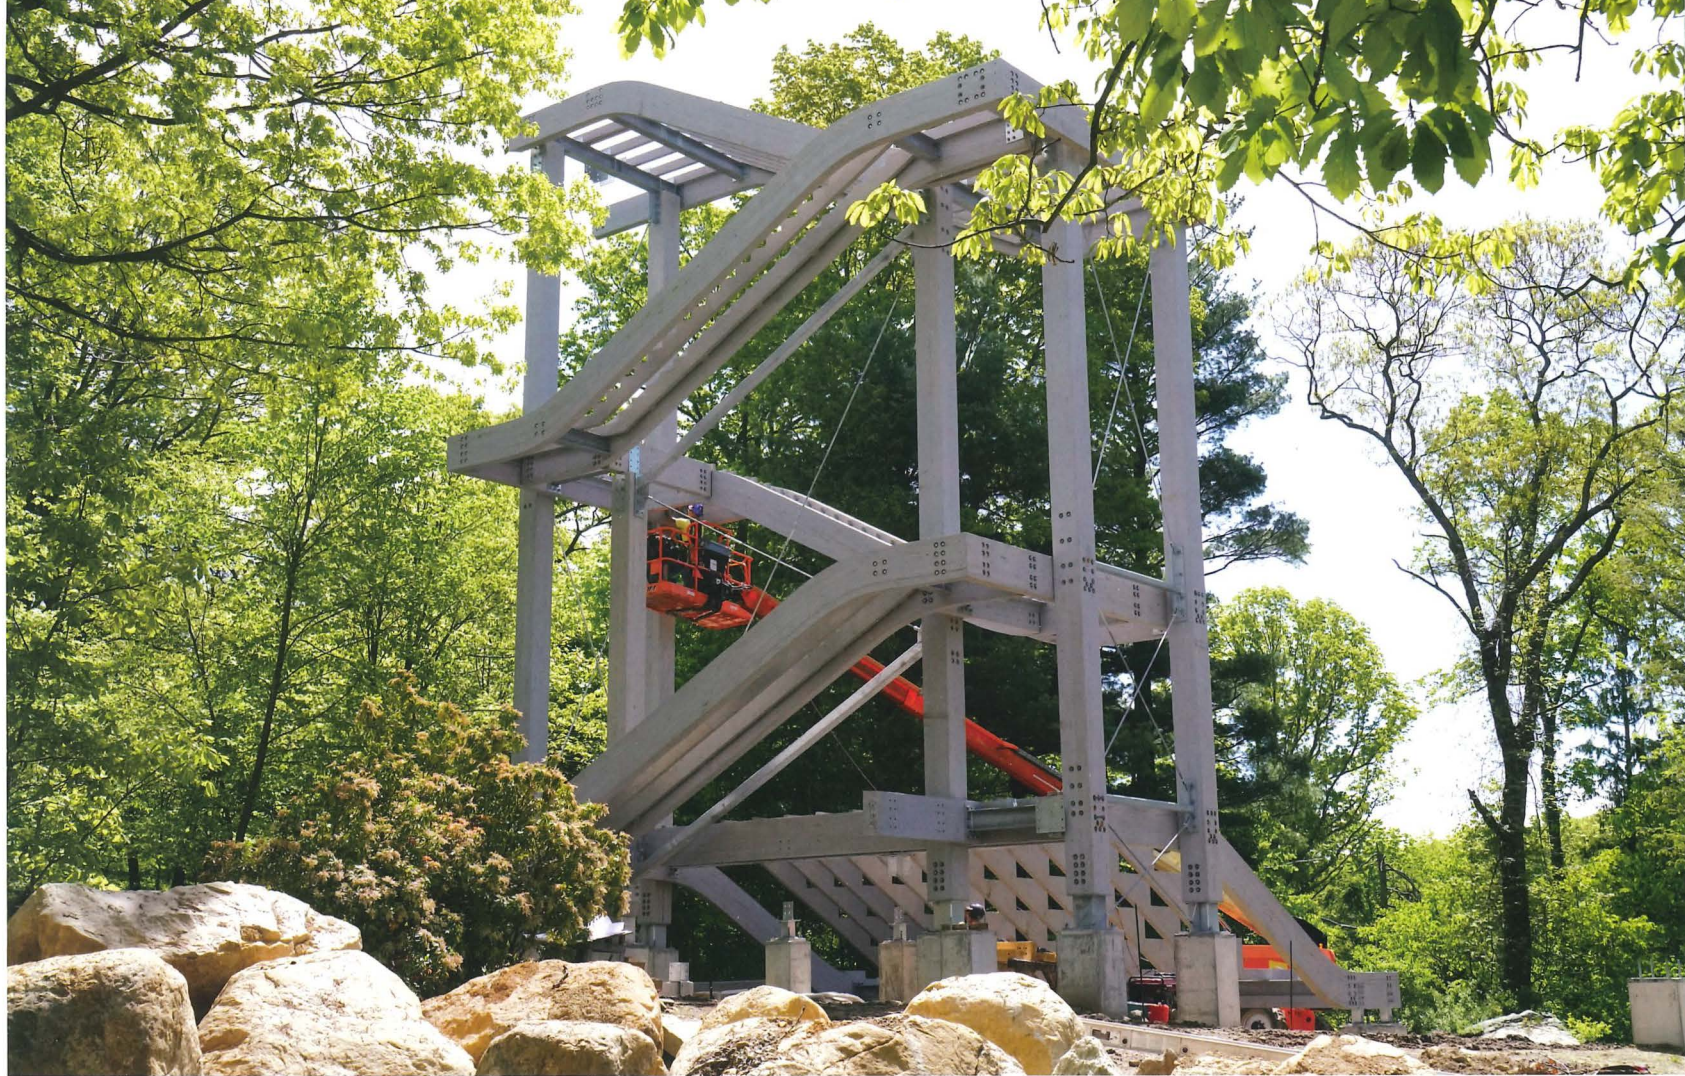
**9** The fully erected Tree House, midway along the walkway. Built-up bleacher and stair stringers installed. There is a large set of bleachers at the lower level and another, smaller set at the top. The main glulam columns here are 16x16, up to 45 ft. long.

(Fig. 9). The Tree House and stair runs were assembled piecemeal on site. We decided to tackle this tower first, since it was the connecting node for the walkway section starting at the existing lodge building and another section connecting the tree house to the “Cabin,” a four-story classroom building that was still in the planning stages.

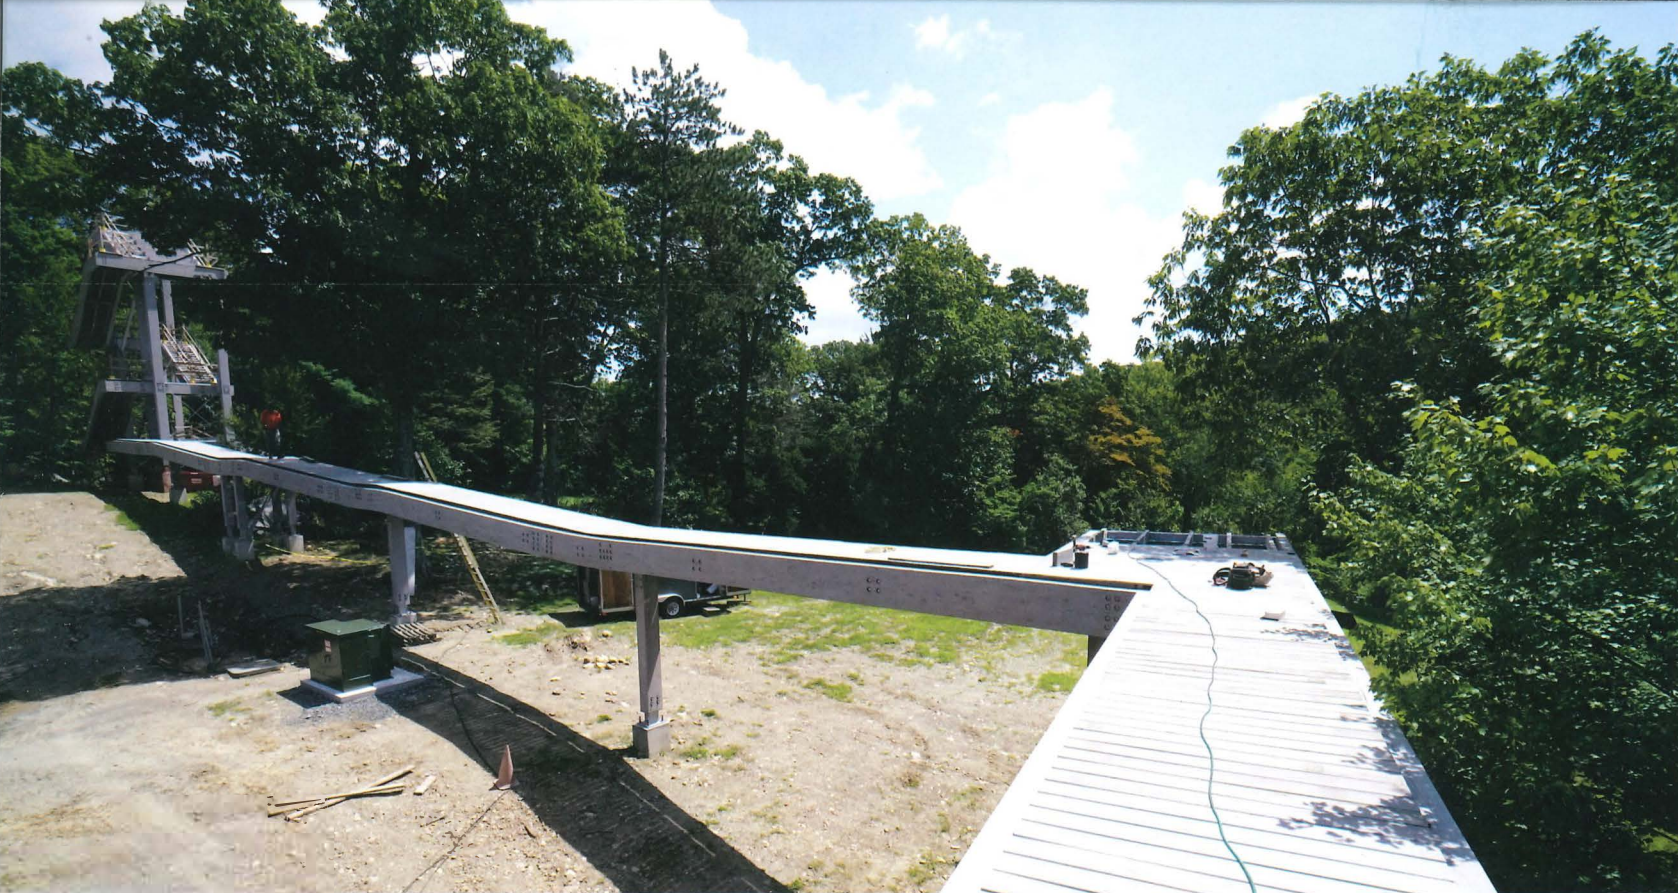
10 View of the partially completed walkway (no railings yet installed) from the existing Lodge building toward the Tree House in the distance.

There was another glitch, again thankfully not of our making. The final brace-frame tower of the walkway, at its last turn toward the Cabin building terminus, landed right in the middle of a road into a parking area. The road ended up being rerouted to bypass the tower. Still, the fact that—after meandering over hill and dale through the woods and over boulder fields—the walkway piers never strayed more than  $\frac{1}{8}$  in. off course was nothing short of miraculous. Chalk it up to technology for once actually simplifying things rather than the opposite (Fig. 10).
