JOURNAL OF THE TIMBER FRAMERS GUILD

Number 138, December 2020

# Rehabilitating the C&O Canal Lock Gates

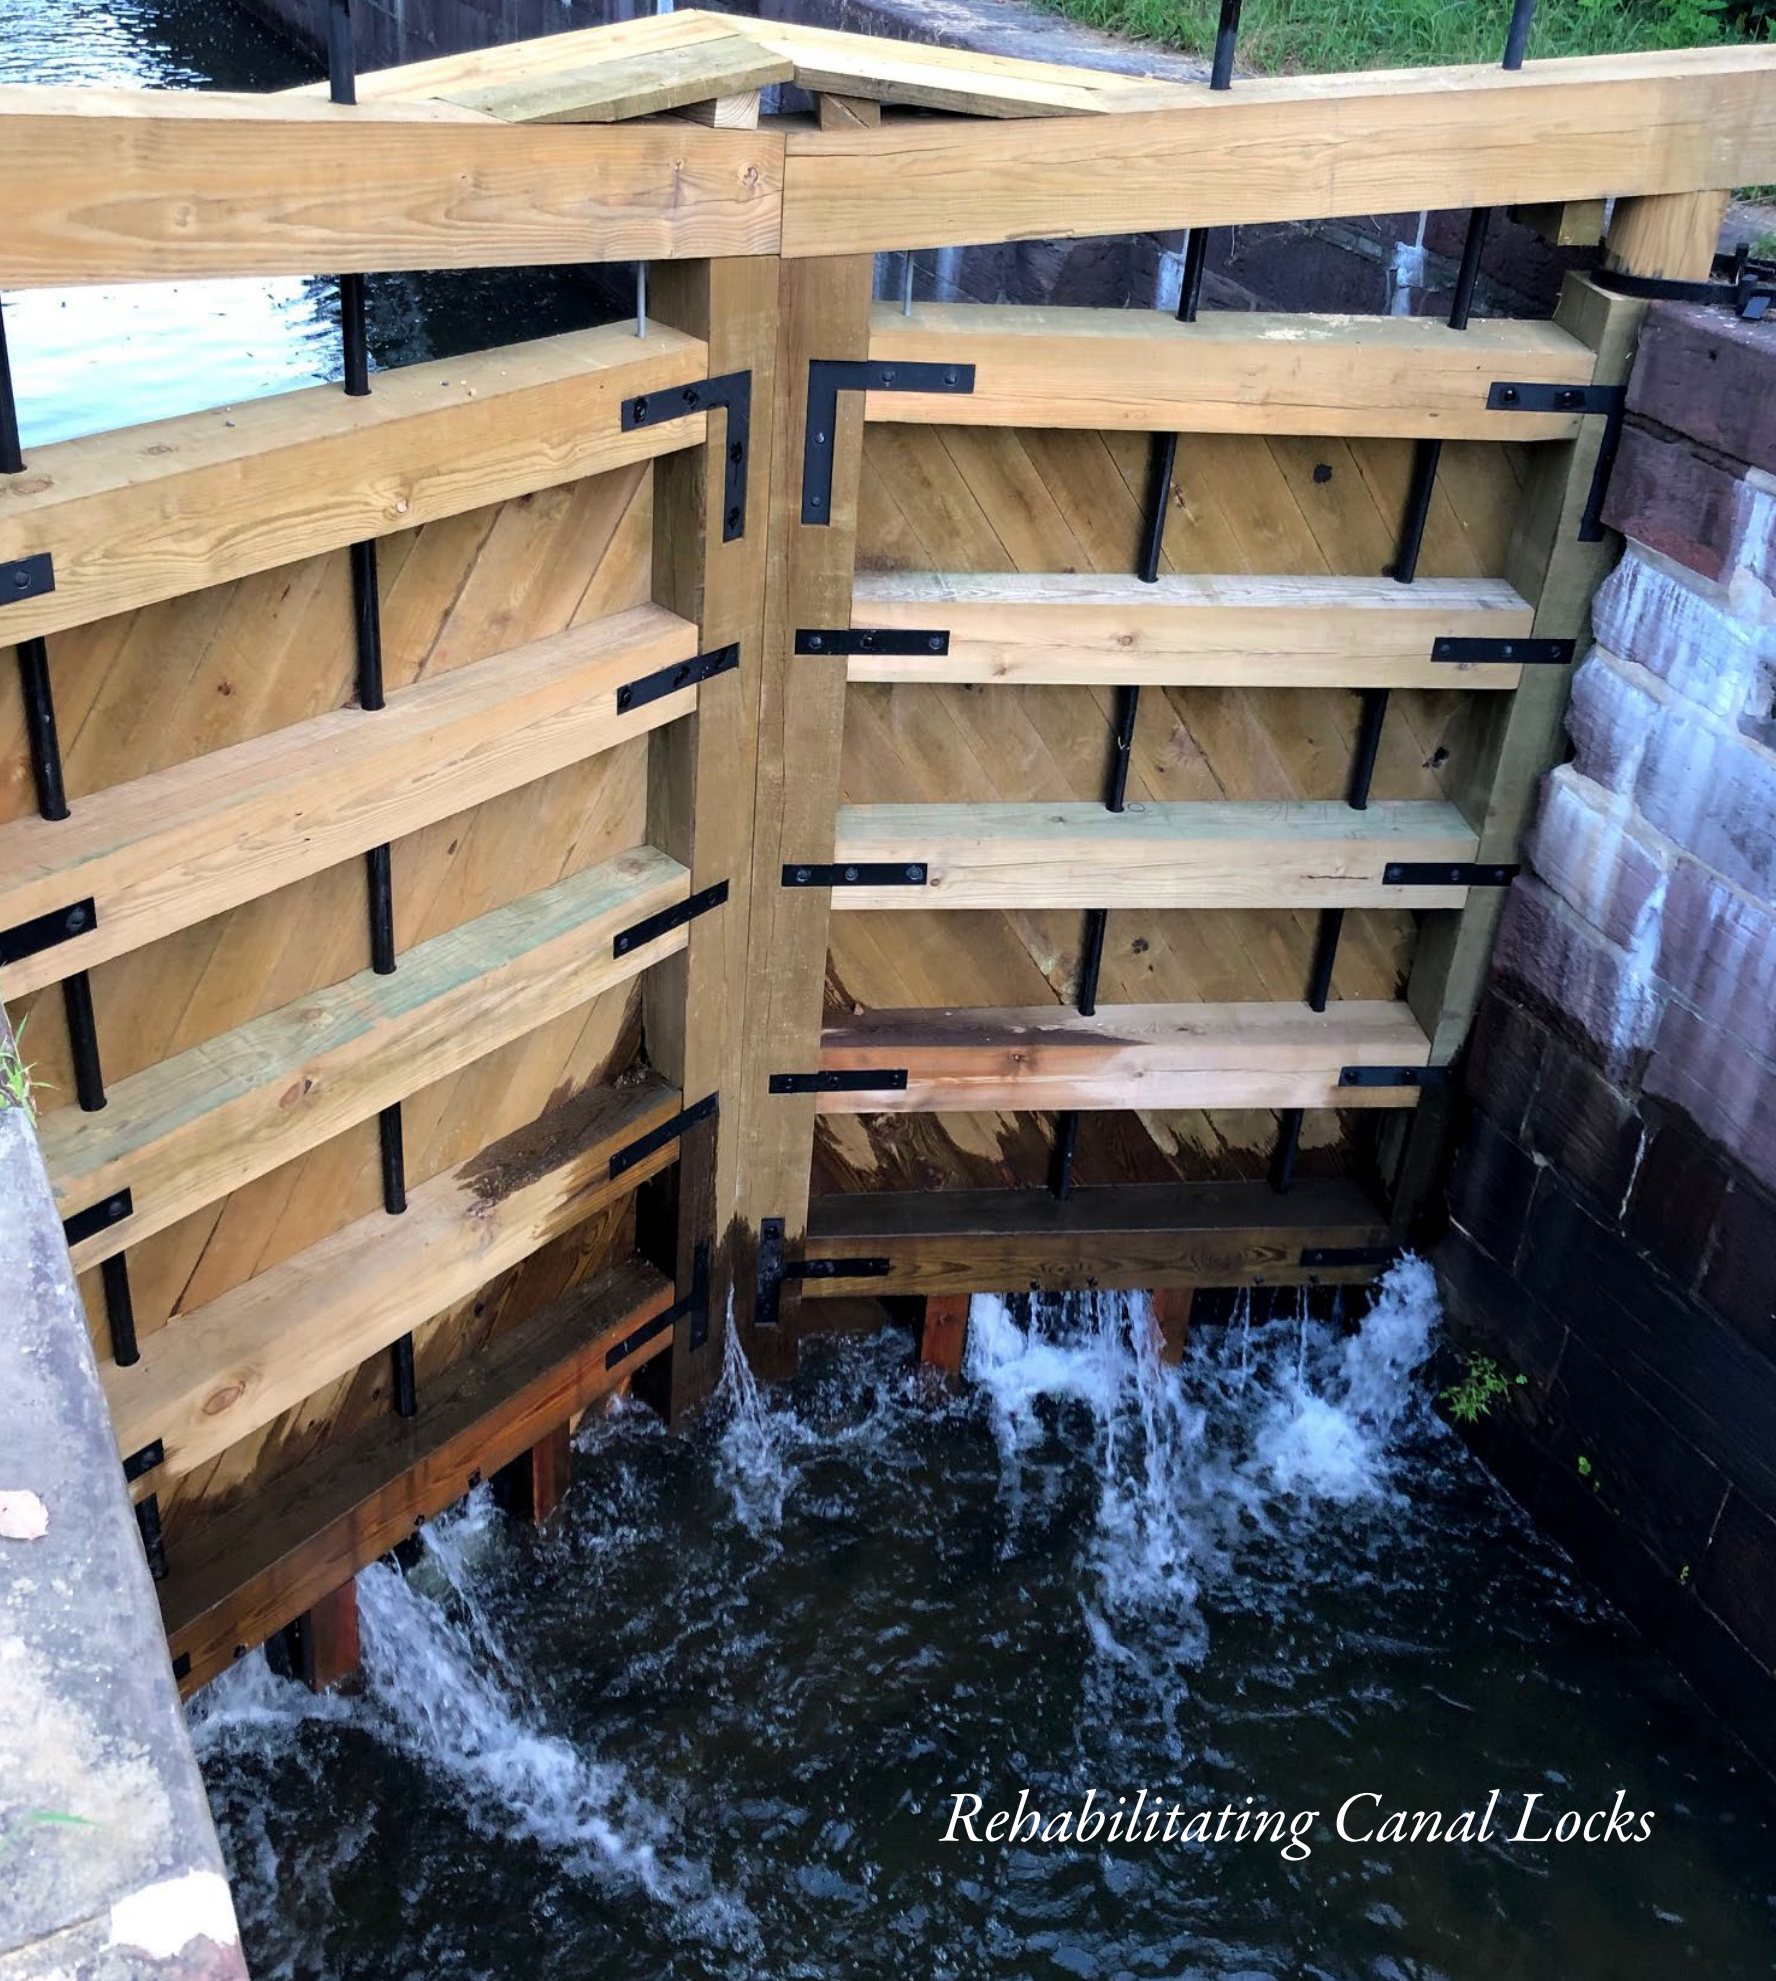
**1 Masonry walls fully exposed. Fighting mud, debris, and driftwood was a constant struggle during the installation process.**

The locks each consist of masonry walls, approximately 100 ft. long, with wooden gates at each end of the lock to control the flow of the water (Fig. 1). The masonry walls are constructed with locally quarried red sandstone, generally measuring 2x3x2 ft. and laid with mortar. The wooden lock gates are opened and closed with a long balance beam which cantilevers away from the gate and can be operated by one person on each side. When the gate panels are open (Fig. 2), they fit into a recess in the masonry wall to prevent interference or contact with the canal boats as they pass through the lock. When the gates are closed, they meet as a miter pointing upstream. The pressure of the water flowing downstream pushes against the gates; consequently, the higher the water level, the tighter the gates get. Paddle valves (Fig. 3) at

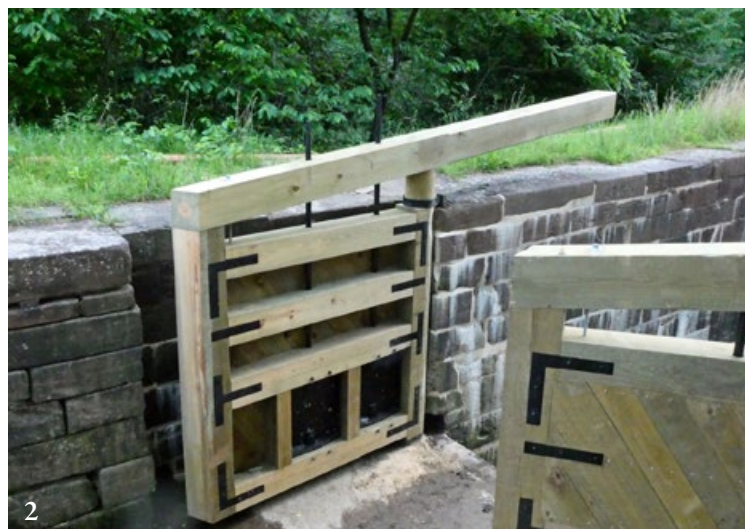
2

**2 When opened, the lock gates fold into the recess in the masonry wall to avoid possible damage to the sides of the canal boats.**

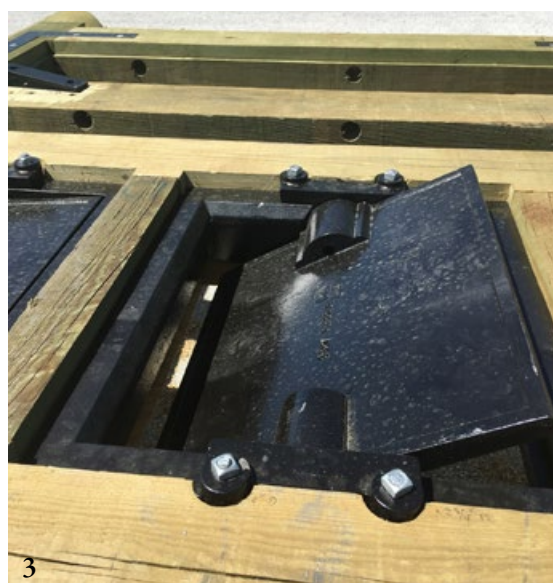
3

**3 Paddle valves located at the bottom of the lock gates are mounted within the frame openings with close tolerances.**

the bottom of each of the gates are operated with a vertical shaft called the valve stem, which extends to the top of the gate where a handle is rotated by the lock operator to open or close the valve. Opening the valve on the downstream gate lowers the water in the lock, while opening the valve on the upstream gate raises the water in the lock.

Fitting the cast-iron paddle valves into their cast-iron frames turned out to be the most challenging aspect of the assembly process. It didn't occur to me to inspect them before we put the whole thing together, but the castings were delivered to us rough, with all the surface inconsistencies from their sand molds preventing a good fit between the valve paddles and frames. Naturally, we had already mounted the frames into the gate panels, so the grinding and fitting process had to be done from underneath the assembled gate panels on a mechanics dolly. In hindsight, we should have done all the grinding and fitting before mounting the valve frames into the gate panels.

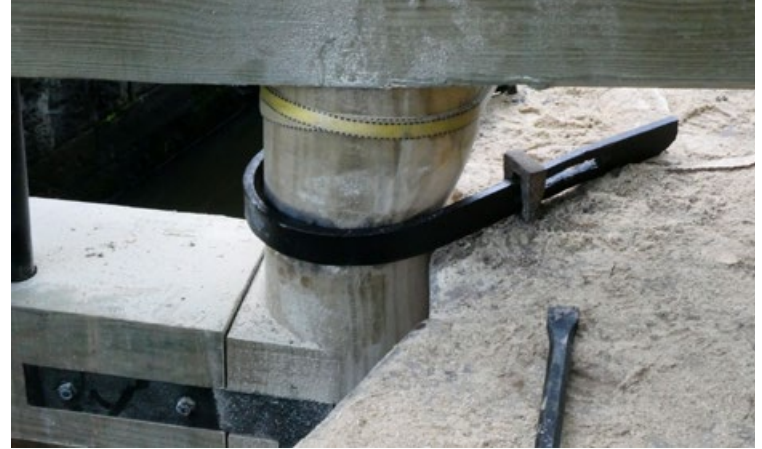
#### 4 Quoin post set in place with collar strap set in the masonry wall.

The timbers of the new replacement gates are pressure-treated with chromated copper arsenate, which is a reduction in toxicity from the creosote treatment used previously. Tapered bearing shoulders where the horizontal rails join into the side of each vertical post also feature prominently in the framing details. This tapered shoulder, which is wider on the upstream face, creates an angled surface that resists the force of the water against the rail, without which the tenon would be loaded in the weak axis and at greater risk of failure. The quoin post,<sup>1</sup> or hinge post, is set into a radiused corner in the masonry at the downstream end of the gate recess, allowing the quoin post to rotate as the gate swings. The only attachment points of the lock gates are a cast-iron bearing plate with a 3-in.-diameter pin set into the end grain at the bottom of the quoin post, and a collar around the upper end of the post that is anchored into the top of the masonry wall (Fig. 4). The bearing pin at the bottom of the quoin post is not anchored at all, but simply rests on the stone at the bottom of the canal floor, which allows the gates, when closed, to press more tightly into the masonry quoin. The collar at the top can be tightened or loosened by adjusting metal shims as needed.

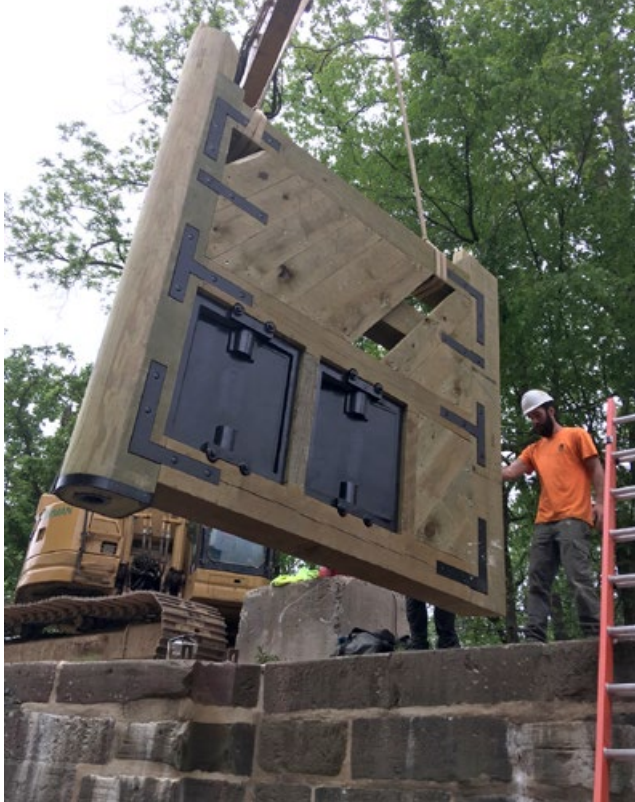
## 5 Installation of lock gates with heavy equipment.

When the canal gates arrived at their respective locations, the rigging was adjusted to lift them vertically and then lower them down into the drained lock (Fig. 5). Once lowered into position, the round part of the hinge posts had to be scribed to fit the masonry walls, ensuring the tightest seal possible. Several cycles of marking, hoisting, and removing material with a chainsaw was necessary to ensure a snug fit. In some cases, the stones had heaved so much that a substantial amount of wood had to be removed to get a good fit (Fig. 6). With both gates scribed to fit into their masonry quoins, the miter cuts were then scribed to fit tightly where the panels met. To close miter and improve the fit, a chainsaw was passed from top to bottom between the miter joint of the adjoining panels until the fit was quite close (Fig. 7), and then a power planer was used to smooth the rough sawn surface. Lastly, the miter sill, which is essentially a horizontally oriented truss, bolted to the floor of the lock, had to be cut to size and assembled (Fig. 8). The miter sill maintains a seal to prevent water flowing under the gates. The upper (upstream) chords of the truss need to be well aligned with the miter gates in their closed position.

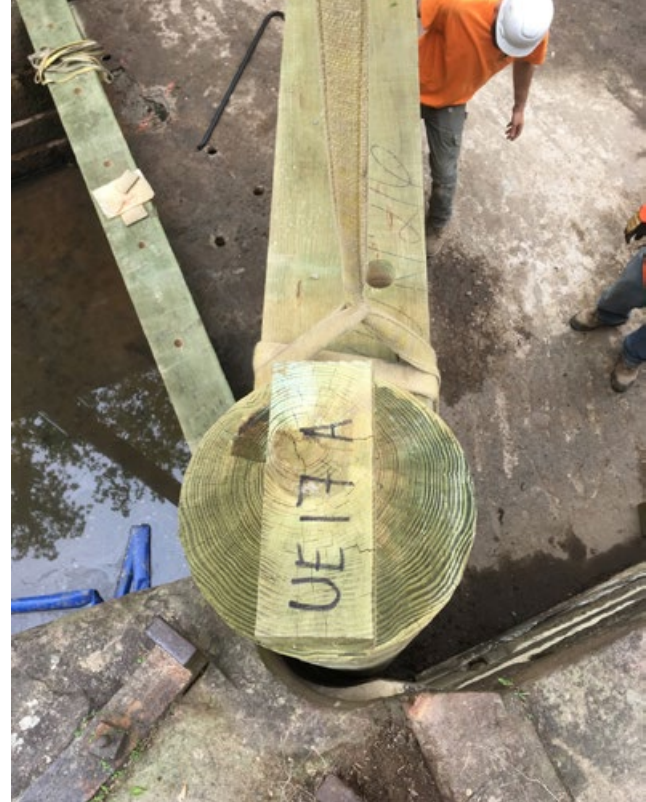
## 6 Quoin post viewed from above shows the fit of the rounded shape into the masonry.

The hinge post requires a semicircular cross section so that the gate can rotate easily in the masonry quoin. To accomplish this, we laid out the profile at each end of the post; then facets were ripped off with a sawmill and the profile smoothed out with a power planer. A plywood pattern was used as a gauge to determine which areas needed to be reduced. The top two feet of the hinge post is completely round, allowing for the steel collar strap to retain the gate in any position. The ripping, in this case, was done with a circular saw, and the profile of the shape was smoothed in the same manner with the power planer.

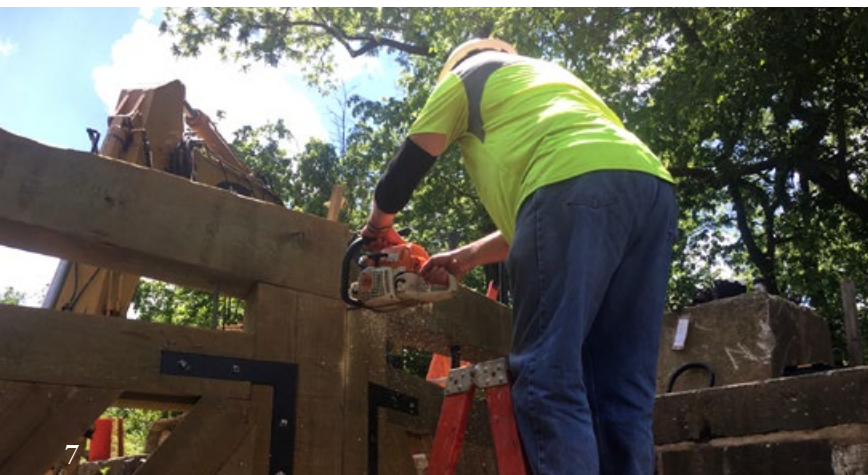
7 Tuning the miter joint between the two gates.

The miter posts, where the two gates meet, were also ripped at the sawmill with the calculated miter angle. This angle was later adjusted in the field once both gates were seated and swung closed. The thickness of the gates tapers from 12 in. at the hinge post to 10 in. at the miter post, which meant that all of the horizontal 12x12 timber rails had to be ripped on the sawmill. We were thankful to have a great sawmill operator who was able to cut all the various rips and tapers. The horizontal rails connect to the vertical posts using 3-in.-thick tenons which seemed unnaturally huge until the whole assembly was put together. The massive proportions of the gate seemed to correlate well with the large joinery. The panel of the gate itself is created using 2x8 boards, oriented diagonally for lateral bracing and seated in rabbets along the edges of the posts and rails. The effect, much like the bolt heads, was a clean, flush face on the canal side of the gate, to prevent damage to the passing canal boats.

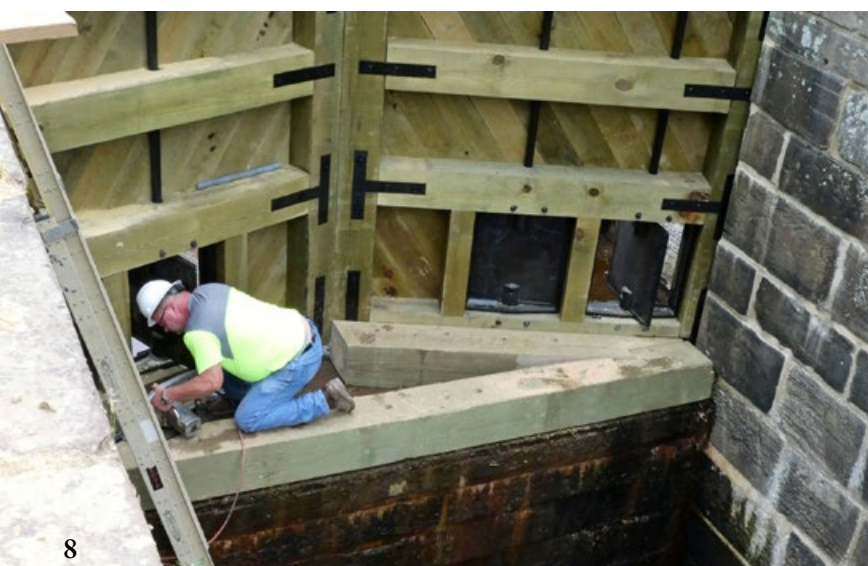
8 The miter sill truss, being cut in place, is anchored to the floor of the lock to help resist the force of the water and to seal the bottom sill of the gates.

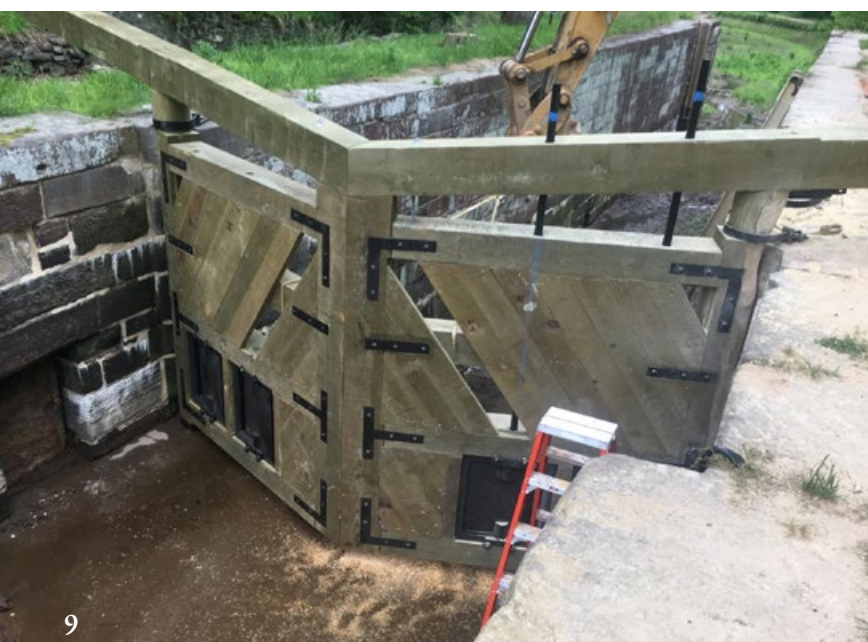
9 Completed lock gate in closed position. Gates are operated using balance beams which cantilever beyond the lock into the towpath.

All field cuts were dressed with a copper-based wood preservative, similar to the chemicals used in the pressure treatment, liberally brushed onto any surfaces that were exposed when the joinery was cut. These trusses were built using pressure-treated 12x12 timbers fixed into place with 2-in.-diameter anchor bolts at 2 ft. on center (Fig. 9).
